CRITERIUM[®] **SCHIMNOWSKI ENGINEERS**

Re: Limited Visual Structural Inspection
Project Location: 1666 Coffman Street, Falcon Heights, Minnesota
Criterium File No.: 19-3977

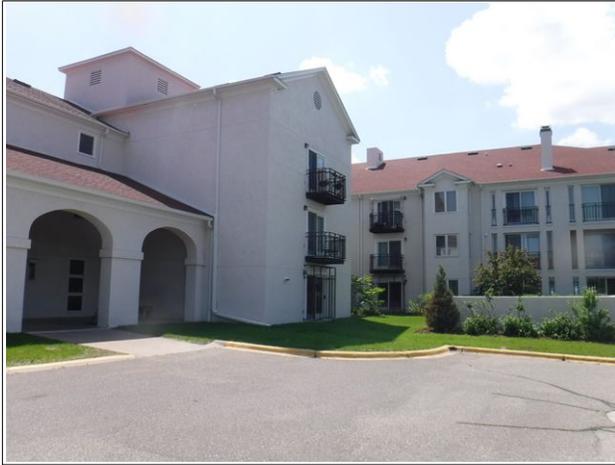
1 Partial front/north side view of building.

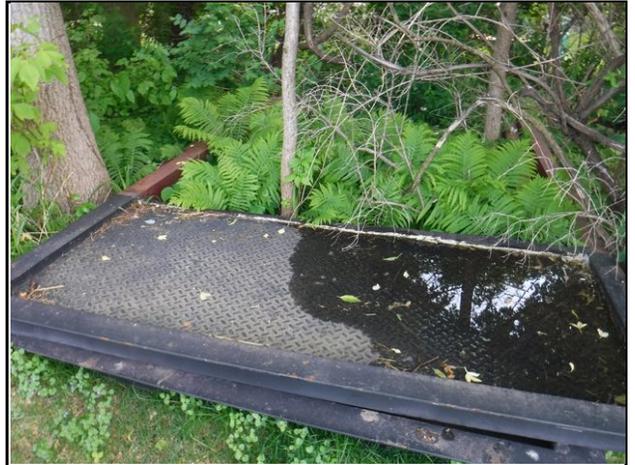
2 Typical steel balcony section (previously removed).

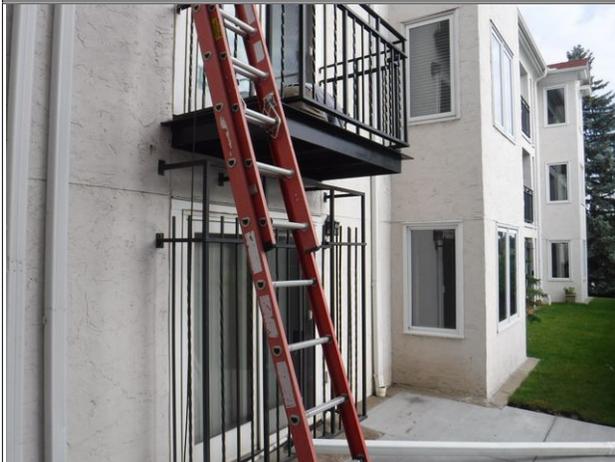
3 Investigation of existing balcony structures.

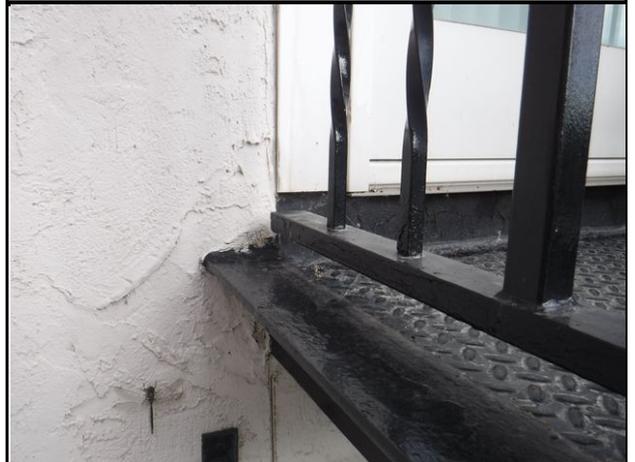
4 View of second level balcony structure at building envelope.

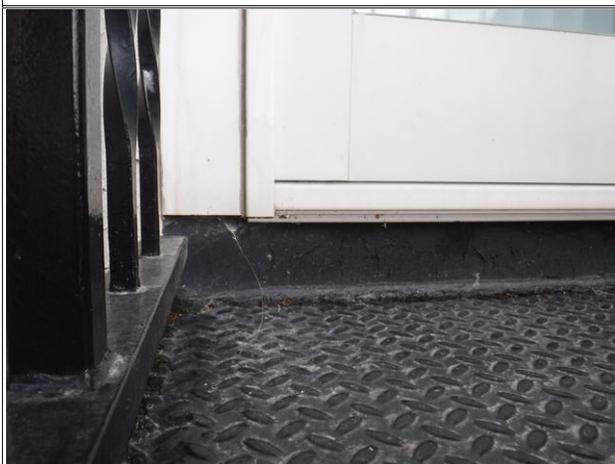
Observations of poor exterior waterproofing details were made. Existing flashing, especially below the doors, is deteriorated and not adequate to prevent water intrusion into the wall system. The overall structural condition of the framing around the cantilevered steel balcony structures is likely fair when compared to others of similar age and construction type. The 'fair' rating can only be confirmed with additional intrusive investigations, but I suspect that extensive structural repairs will be needed. You should expect similarly deteriorated conditions to Unit 108 which was previously repaired.

5 View of flashing with failed sealant under doorway at balcony structure.

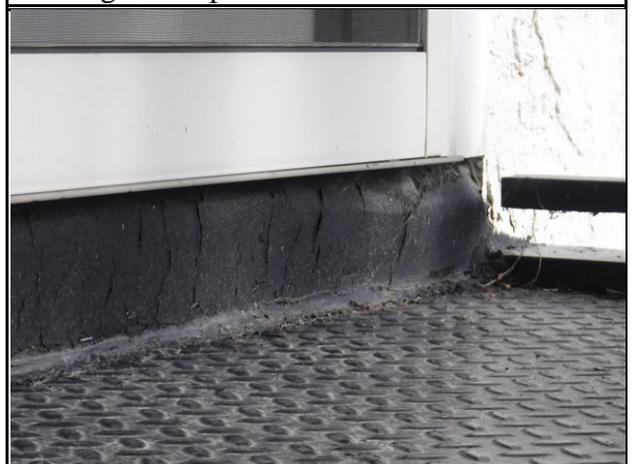
6 View of deteriorated flashing under doorway at balcony structure.

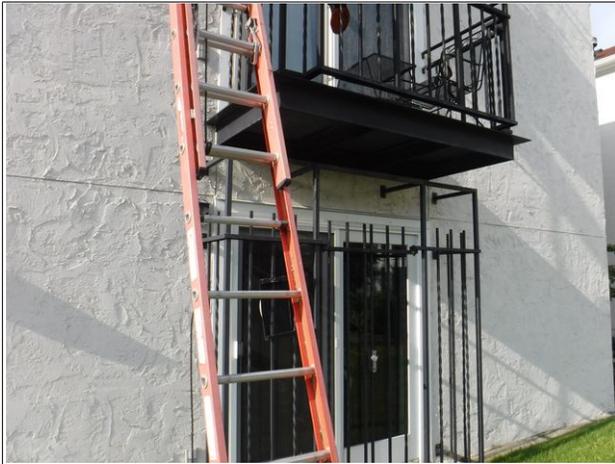
7 Investigation of existing balcony structures.

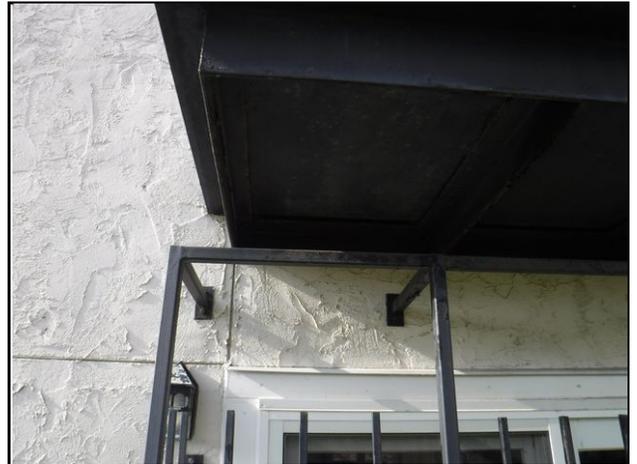
8 View of second level balcony structure at penetration through structure.

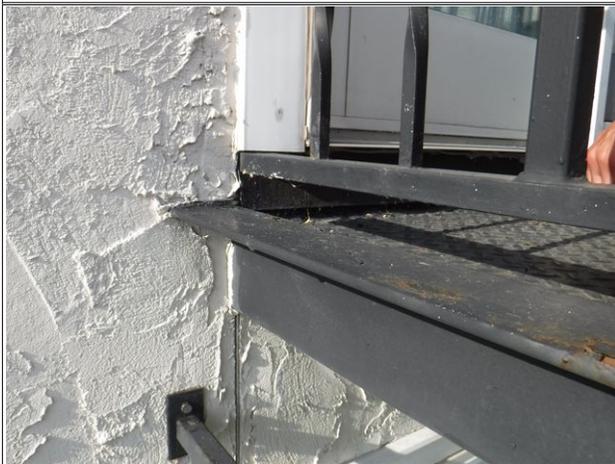
9 View of second level balcony structure at penetration through structure.

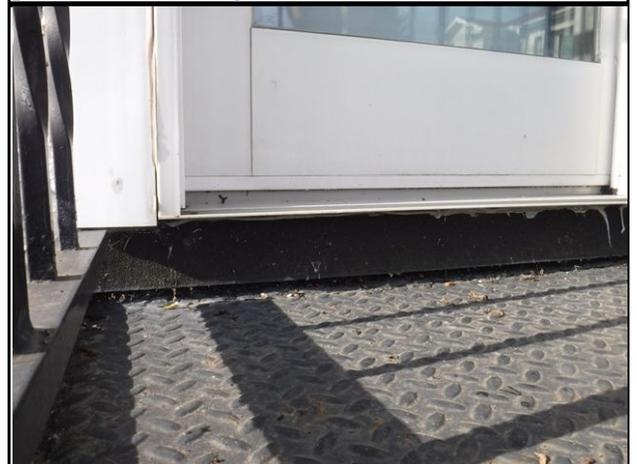
10 View of flashing under doorway at balcony structure.

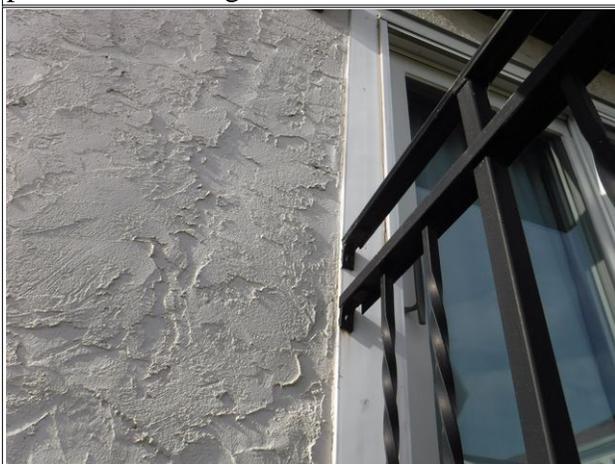
11 Door framing previously modified. Possible source of water intrusion.

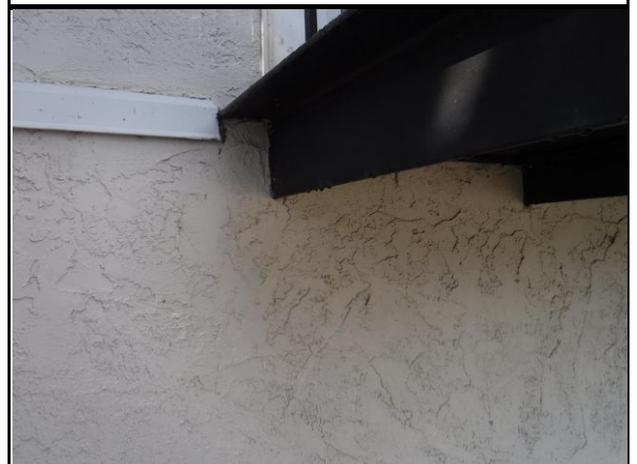
12 View of second level balcony structure at penetration through structure.

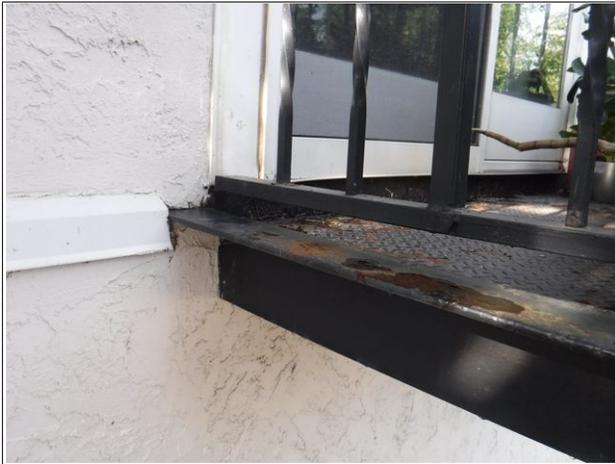
13 View of second level balcony structure at penetration through structure.

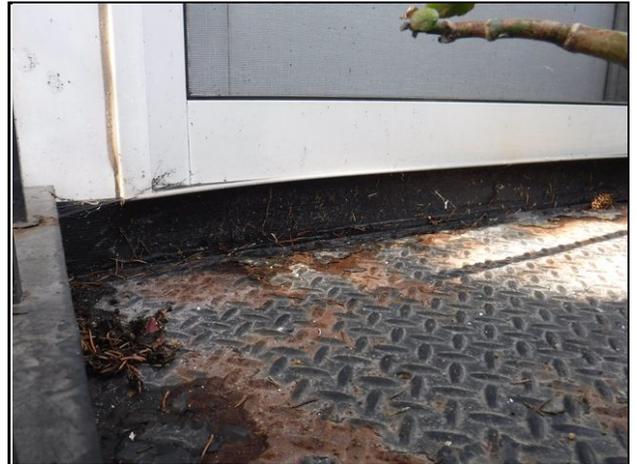
14 View of flashing with failed sealant under doorway at balcony structure.

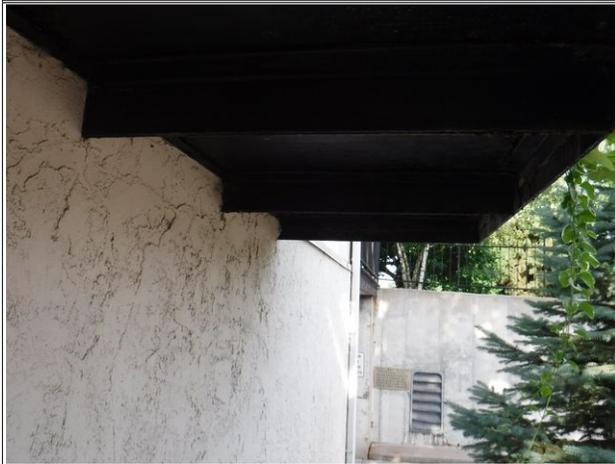
15 View of second level balcony structure at penetration through structure.

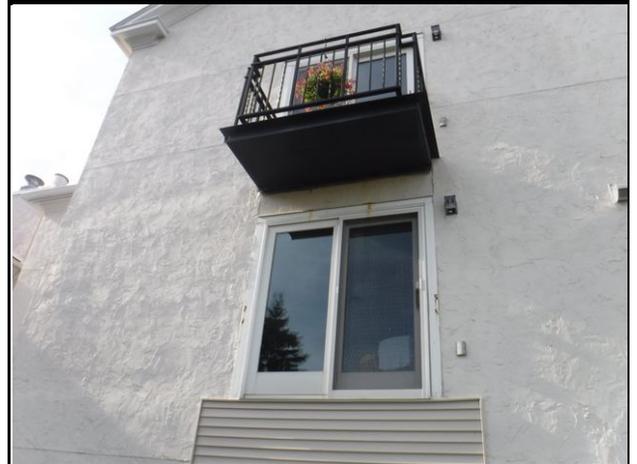
16 Area of previous repairs.
