2022 EXTERIOR FACADE REPAIR PROJECT - PHASE II

CITYVIEW CO-OP
1811 ELLIOT AVENUE SOUTH
MINNEAPOLIS, MN

SHEET TITLE:
TITLE SHEET

PHASE II PERMIT SET 2/18/2022

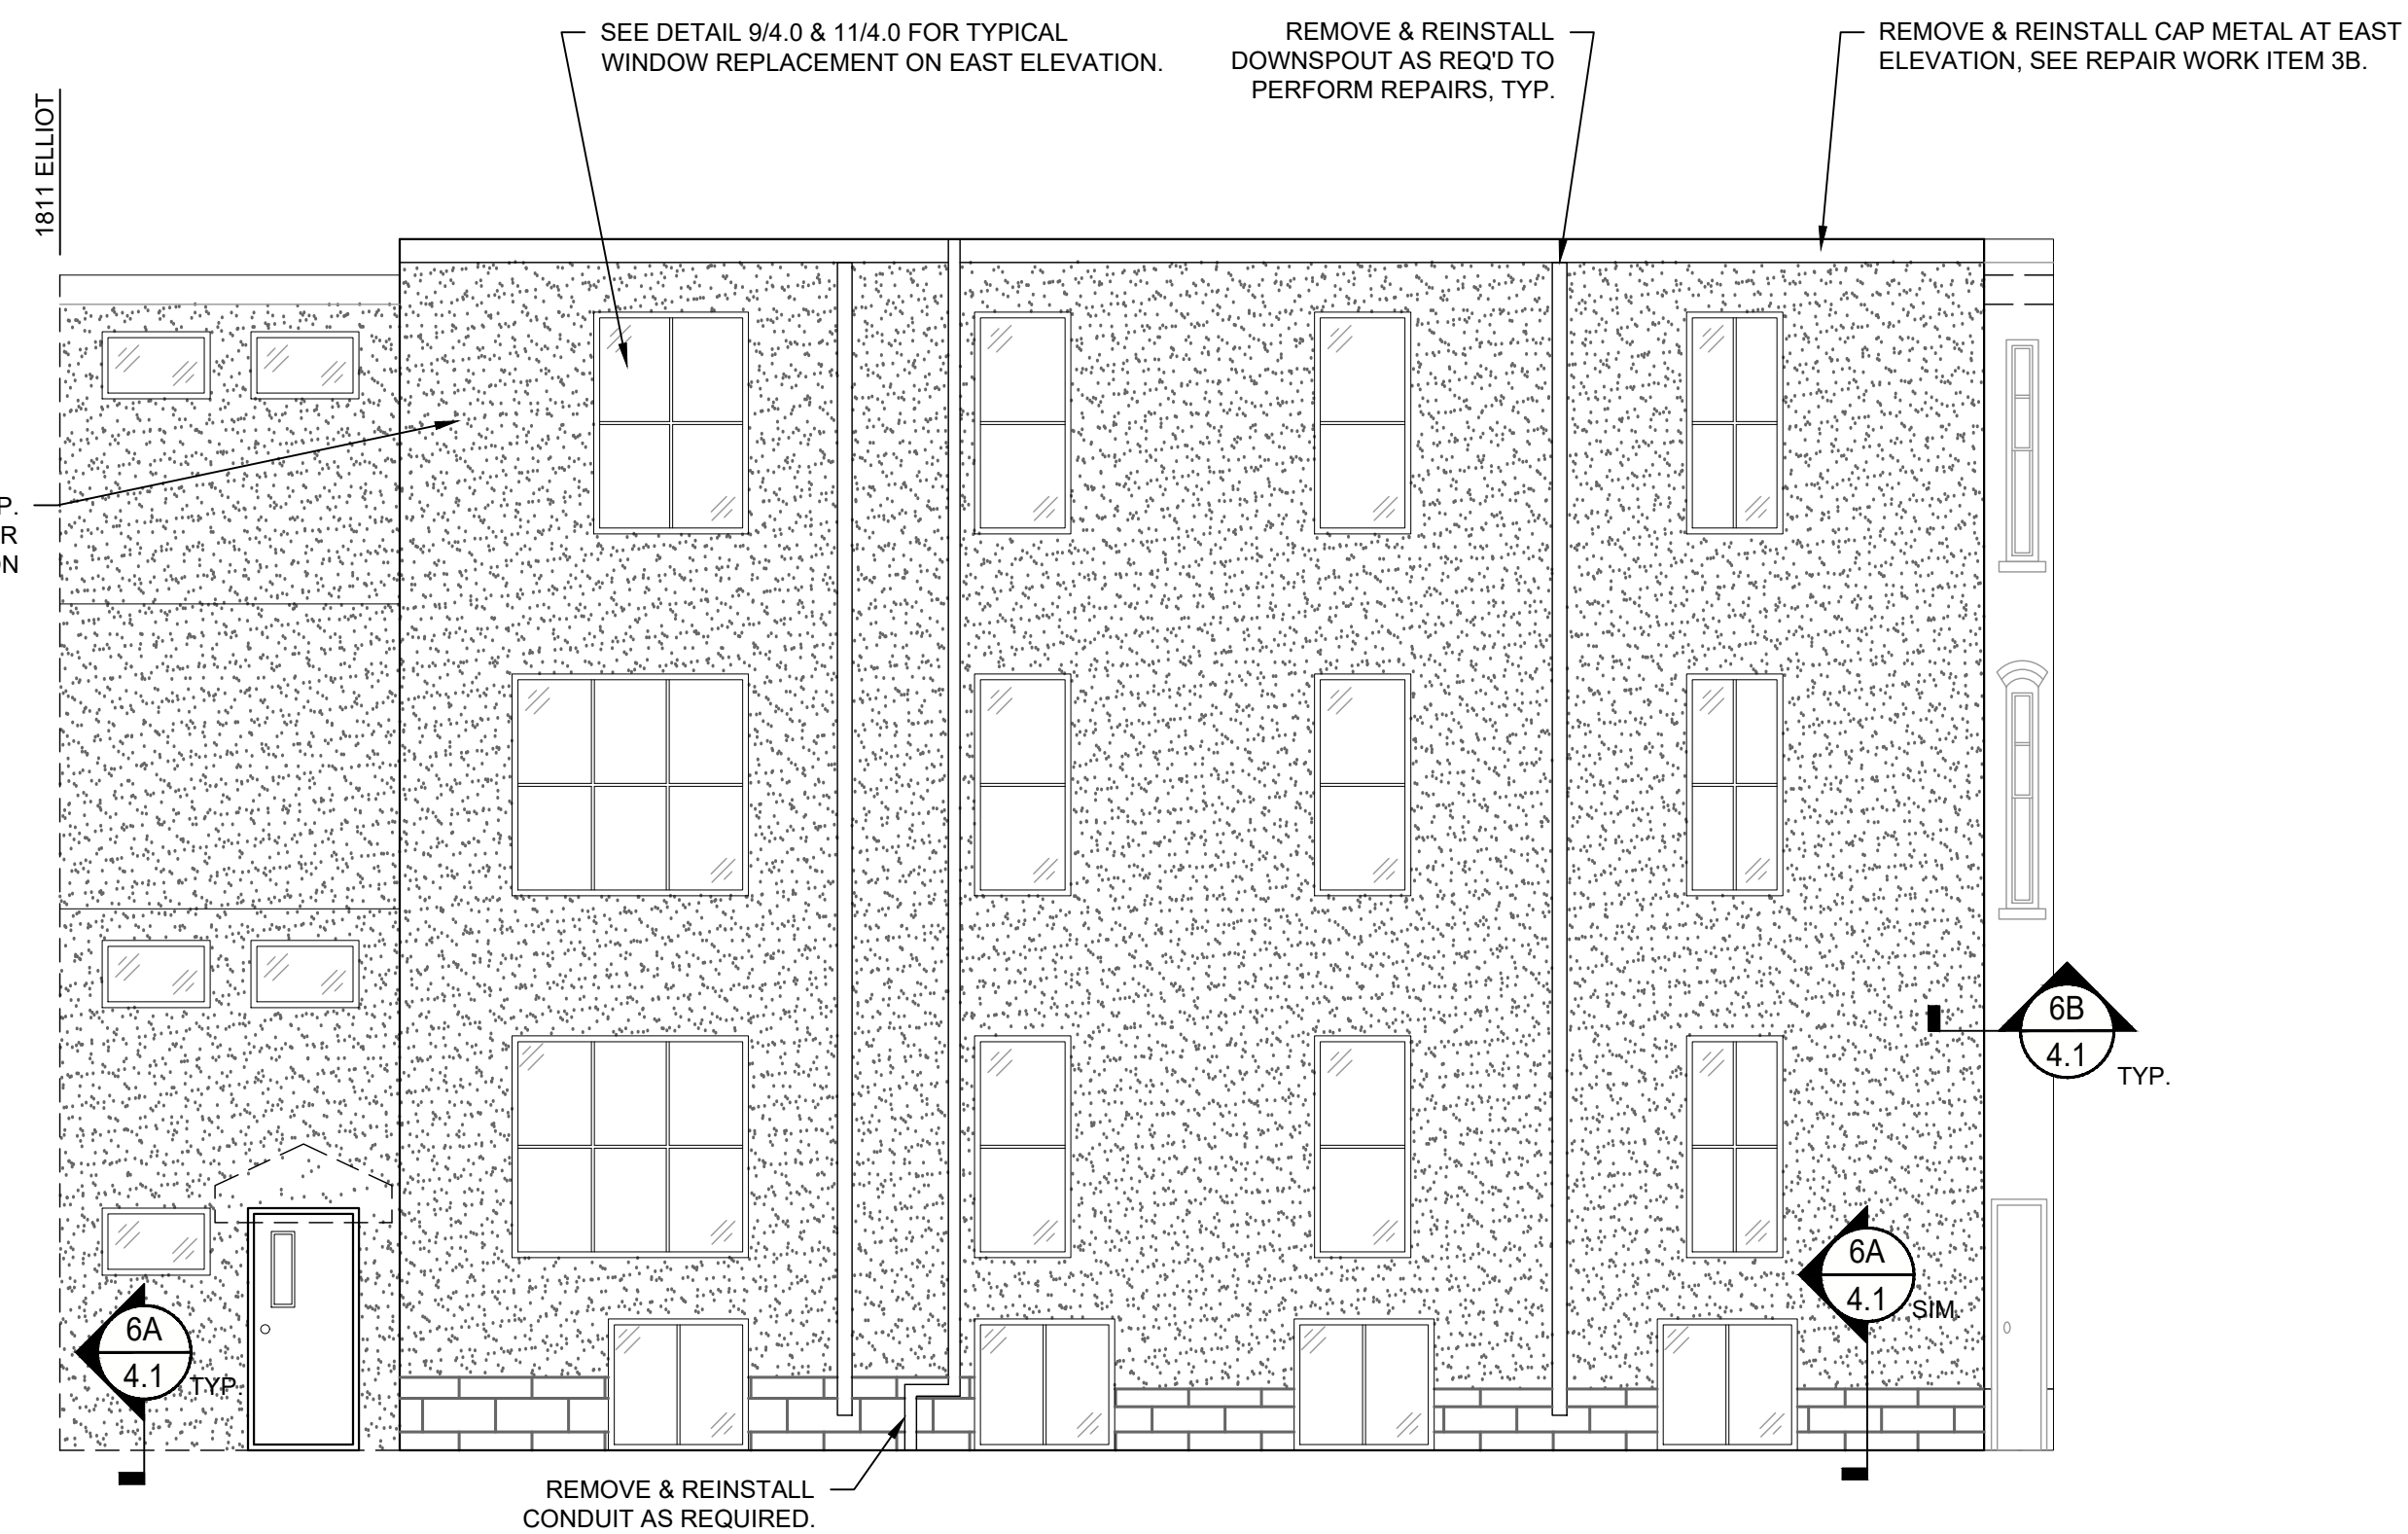
1807 ELLIOT
 EAST ELEVATION (REAR)
 1/3.0 SCALE: 3/16" = 1'-0"

1807 ELLIOT - EAST ELEVATION NOTES:

1. REMOVE AND DISPOSE OF ALL STUCCO, EXTERIOR SHEATHING, AND BATT INSULATION TO EXPOSE WALL FRAMING. SEE REPAIR WORK ITEM 4A.
2. SUBSTANTIAL WALL FRAMING DAMAGES ARE ANTICIPATED. PROVIDE SHORING, TEMPORARY BRACING, AND OVERHEAD PROTECTION AS REQUIRED TO PERFORM REPAIRS. CONTRACTOR TO BE RESPONSIBLE FOR THE MEANS AND METHODS OF CONSTRUCTION. REFERENCE REPAIR WORK ITEM 4B FOR BARRICADES, ENCLOSURES, AND SHORING.

3. REMOVE AND REPLACE ALL WINDOWS. SEE DETAILS AND REPAIR WORK ITEM 6 FOR ADDITIONAL INFORMATION.
4. REPAIR WATER DAMAGED FRAMING AND RECONSTRUCT WALL. SEE REPAIR WORK ITEM 4C FOR TYPICAL REPAIRS TO FRAMING MEMBERS FOR RECONSTRUCTION OF WALL.

5. PERFORM MOLD REMEDIATION IN ACCORDANCE WITH THE DIRECTIONS PROVIDED BY THE INDEPENDENT THIRD-PARTY MOLD TESTING AGENT. SEE REPAIR WORK ITEM 8.
6. DEMOLITION AND REPAIRS TO LIKELY RESULT IN DRYWALL NAIL POPS, CRACKS, AND NEW FASTENERS INSTALLED THROUGH EXISTING DRYWALL. REPAIR DRYWALL AT INTERIOR OF HOMES FOLLOWING SIDING AND TRIM INSTALLATION. SEE REPAIR WORK ITEM 4D FOR INTERIOR DRYWALL REPAIRS.

7. REPLACE ALL STUCCO WITH FIBER-CEMENT LAP SIDING AND TRIM. INSTALL 6-INCH TRIM AROUND ALL WINDOWS, WALL PENETRATIONS, AND ALONG MATERIAL TRANSITIONS. SEE REPAIR WORK ITEM 4E AND REPAIR DETAILS FOR ADDITIONAL INFORMATION.

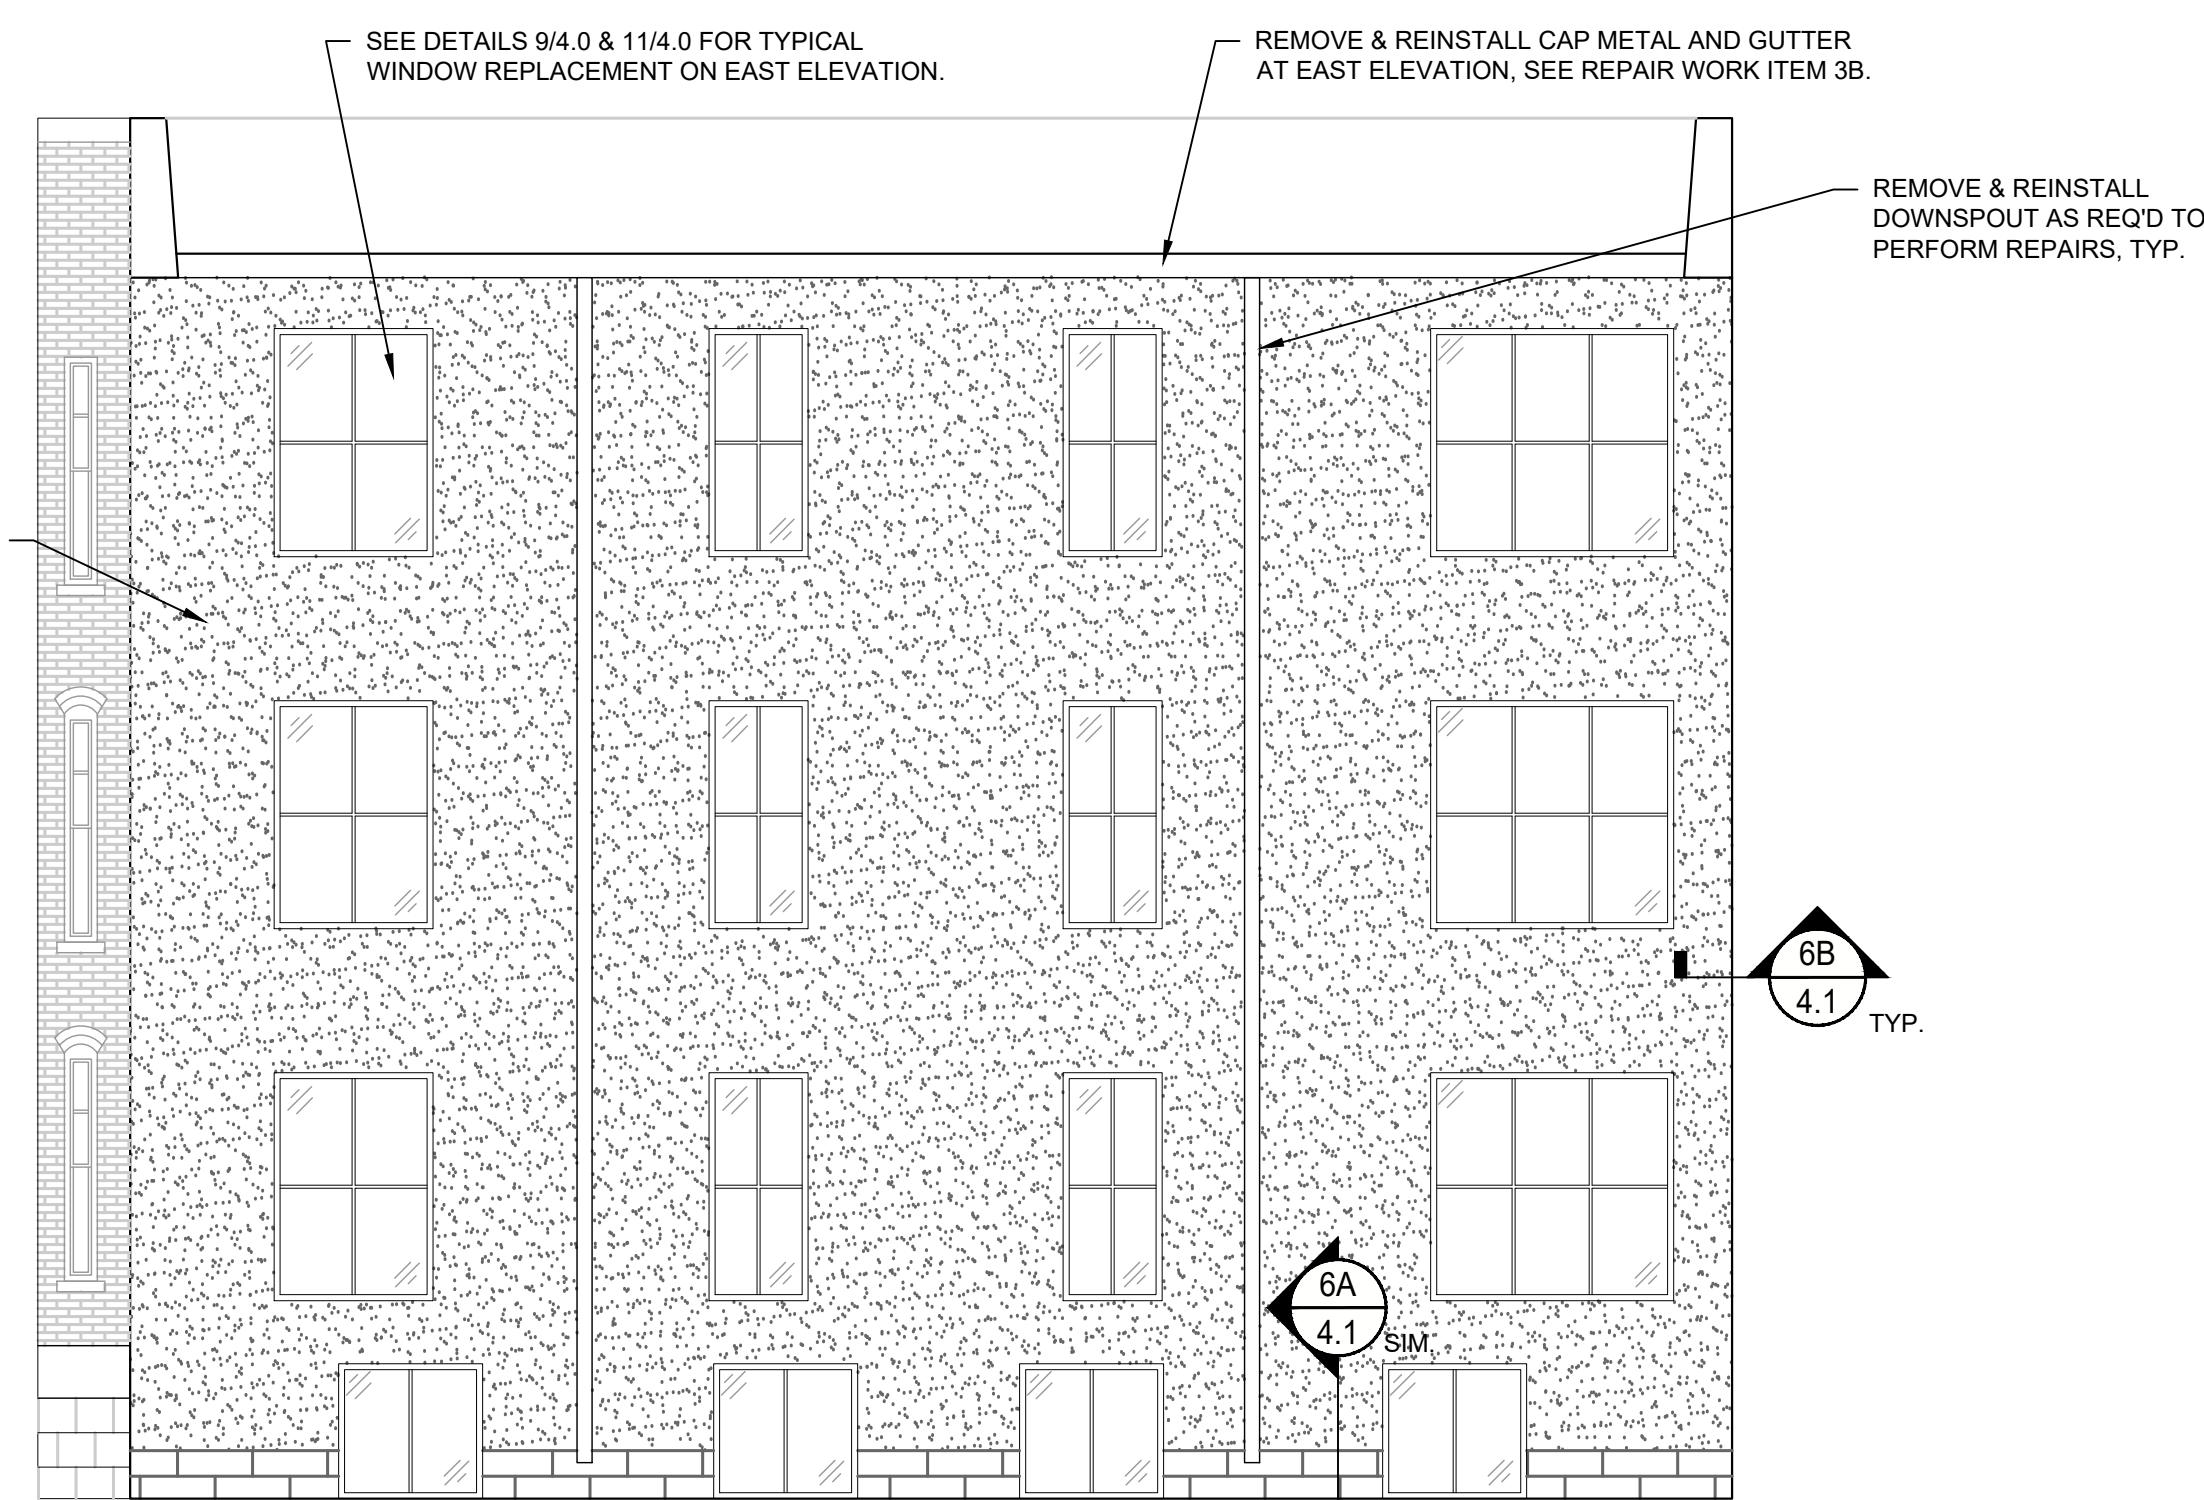
1811 ELLIOT
 EAST ELEVATION (REAR)
 2/3.0 SCALE: 3/16" = 1'-0"

1811 ELLIOT - EAST ELEVATION NOTES:

1. REMOVE AND DISPOSE OF ALL STUCCO, EXTERIOR SHEATHING, AND BATT INSULATION TO EXPOSE WALL FRAMING. SEE REPAIR WORK ITEM 4A.
2. SUBSTANTIAL WALL FRAMING DAMAGES ARE ANTICIPATED. PROVIDE SHORING, TEMPORARY BRACING, AND OVERHEAD PROTECTION AS REQUIRED TO PERFORM REPAIRS. CONTRACTOR TO BE RESPONSIBLE FOR THE MEANS AND METHODS OF CONSTRUCTION. REFERENCE REPAIR WORK ITEM 4B FOR BARRICADES, ENCLOSURES, AND SHORING.

3. REMOVE AND REPLACE ALL WINDOWS. SEE DETAILS AND REPAIR WORK ITEM 6 FOR ADDITIONAL INFORMATION.
4. REPAIR WATER DAMAGED FRAMING AND RECONSTRUCT WALL. SEE REPAIR WORK ITEM 4C FOR TYPICAL REPAIRS TO FRAMING MEMBERS FOR RECONSTRUCTION OF WALL.

5. PERFORM MOLD REMEDIATION IN ACCORDANCE WITH THE DIRECTIONS PROVIDED BY THE INDEPENDENT THIRD-PARTY MOLD TESTING AGENT. SEE REPAIR WORK ITEM 8.
6. DEMOLITION AND REPAIRS TO LIKELY RESULT IN DRYWALL NAIL POPS, CRACKS, AND NEW FASTENERS INSTALLED THROUGH EXISTING DRYWALL. REPAIR DRYWALL AT INTERIOR OF HOMES FOLLOWING SIDING AND TRIM INSTALLATION. SEE REPAIR WORK ITEM 4D FOR INTERIOR DRYWALL REPAIRS.

7. REPLACE ALL STUCCO WITH FIBER-CEMENT LAP SIDING AND TRIM. INSTALL 6-INCH TRIM AROUND ALL WINDOWS, WALL PENETRATIONS, AND ALONG MATERIAL TRANSITIONS. SEE REPAIR WORK ITEM 4E AND REPAIR DETAILS FOR ADDITIONAL INFORMATION.

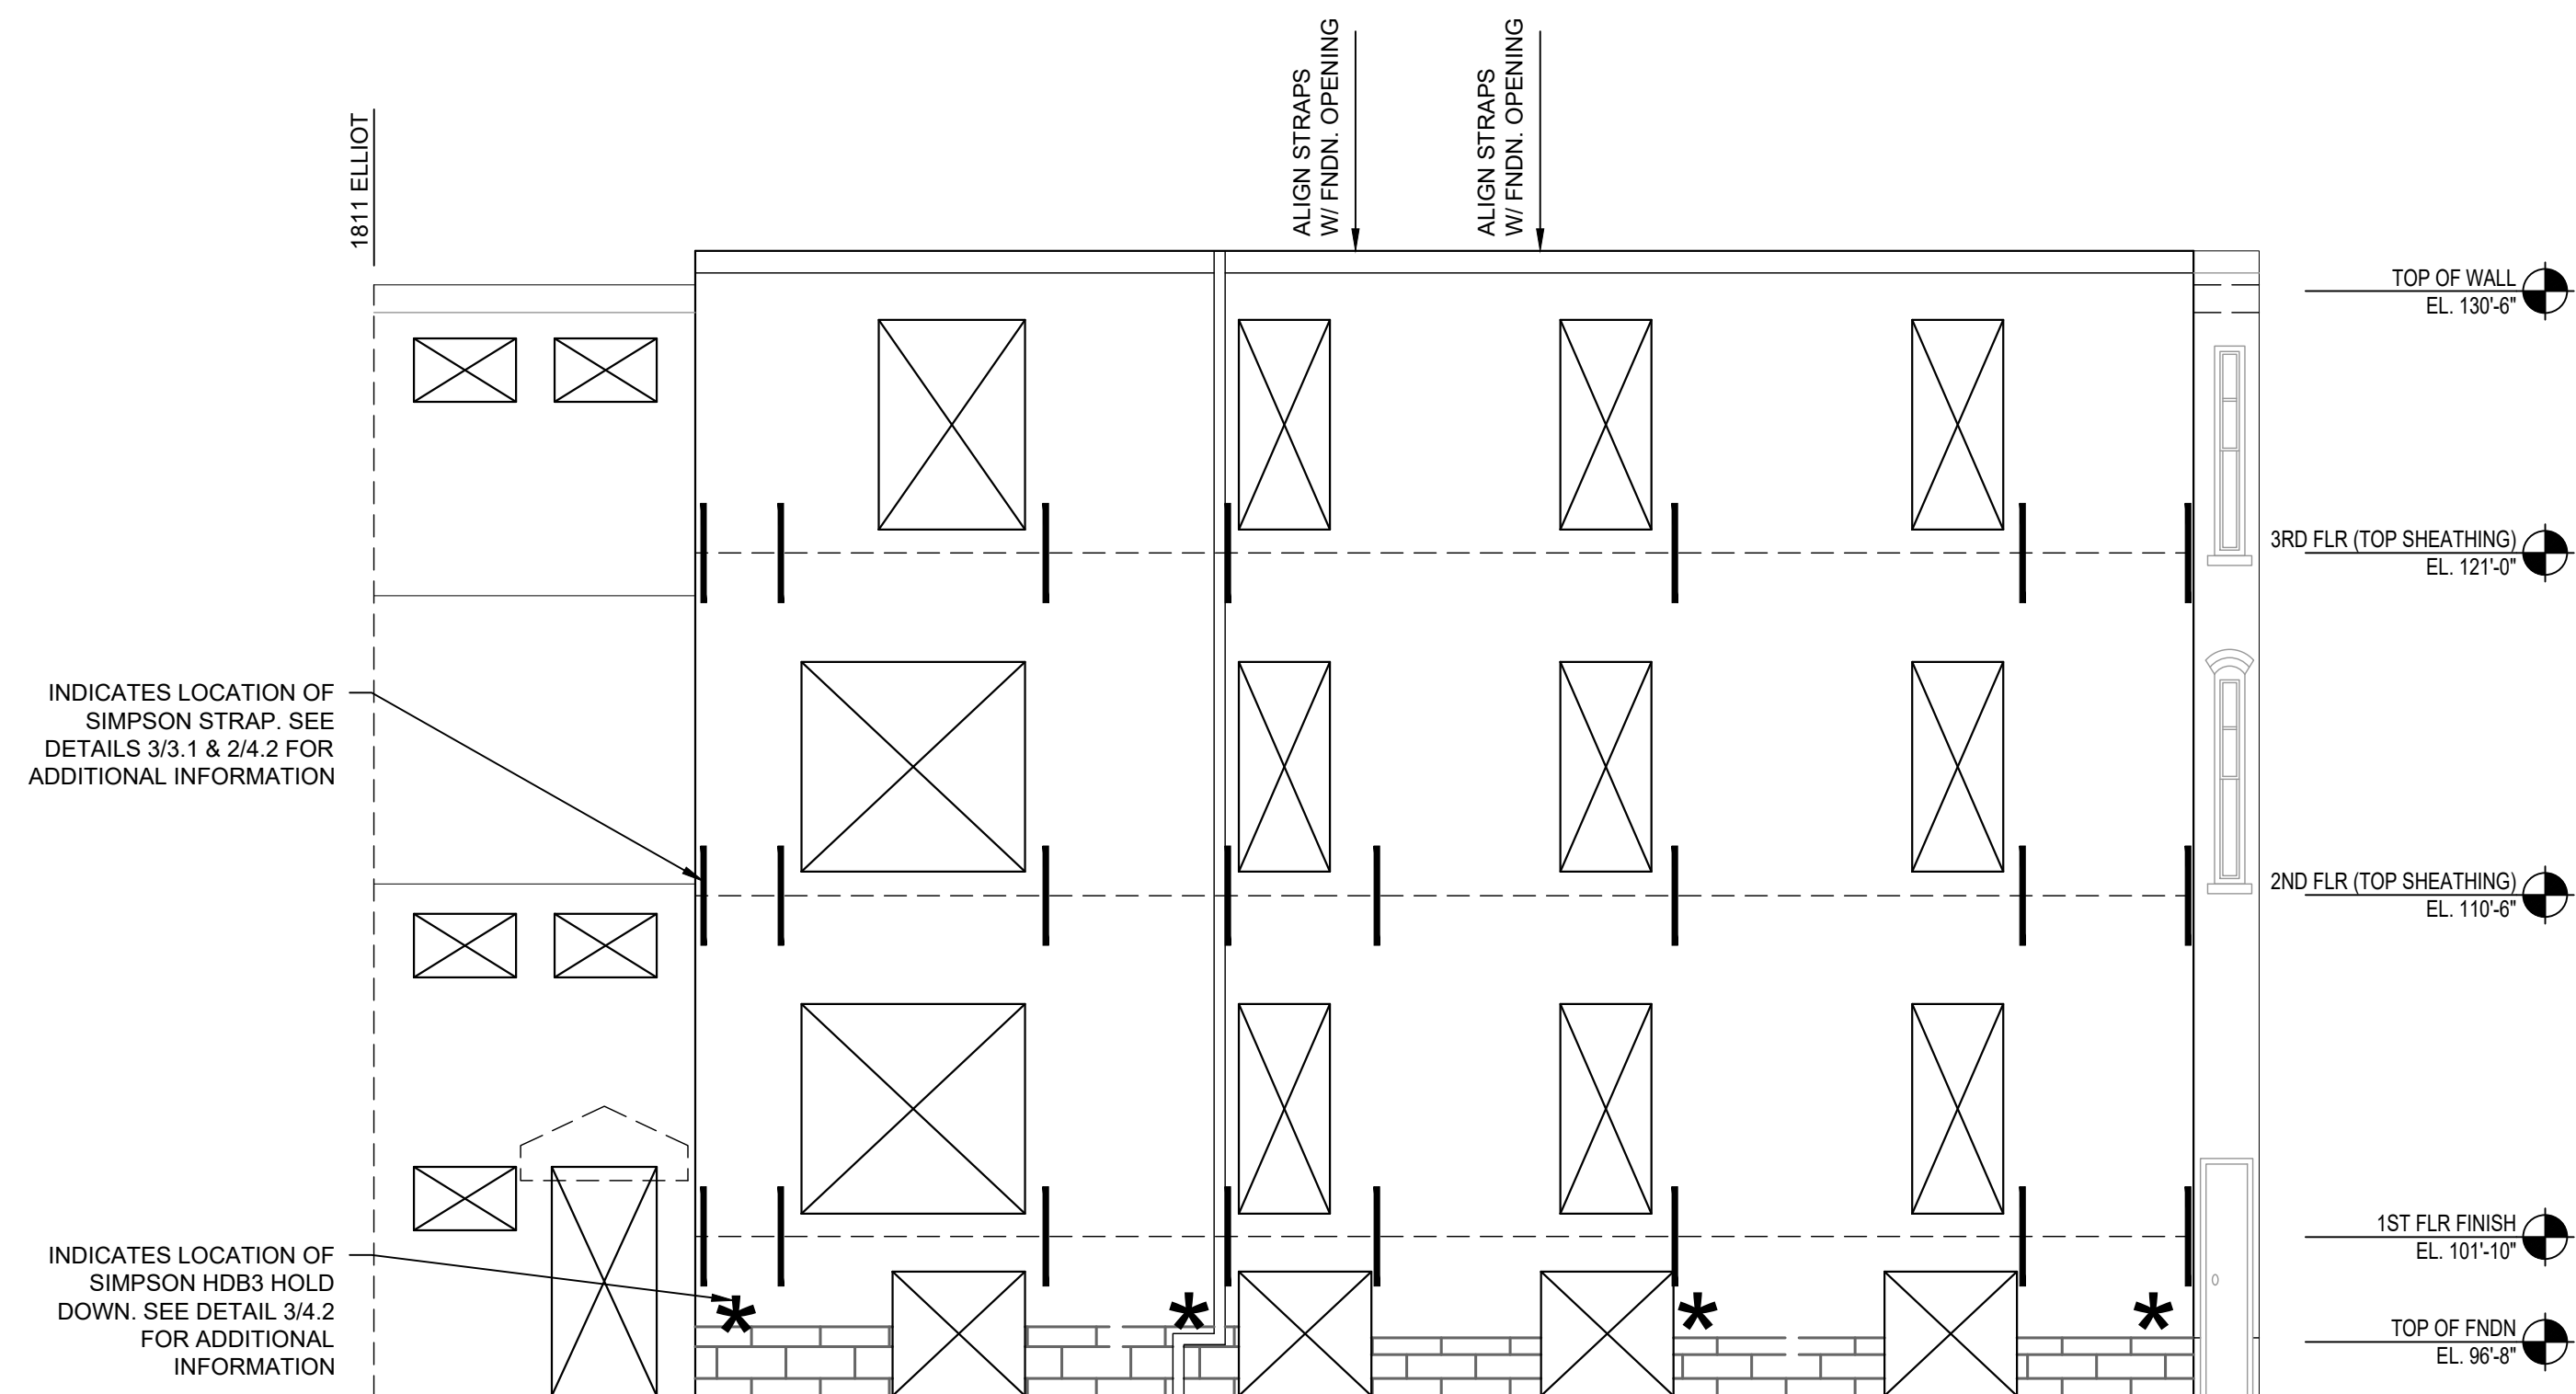
**1807 ELLIOT
 EAST ELEVATION (REAR)**
 1/3.1 SCALE: 3/16" = 1'-0"

1. ORIGINAL WALL CONSTRUCTION CONSISTS OF 2x4 ROUGH SAWN LUMBER WITH 5/8" INTERIOR DRYWALL AND 3/4" TONGUE AND GROOVE PLANKS.
2. EXISTING 3/4" TONGUE AND GROOVE PLANKS WERE REMOVED & DISPOSED OF DUE TO EXTERIOR WATER INTRUSION DAMAGES.

3. REPAIR TO CONSIST OF CUTTING & REMOVING PORTIONS OF WATER DAMAGED STUD FARMING AND REINFORCING EXISTING STUDS WITH 2x4 SPF MSR-2400/2.0E FULL HEIGHT STUDS. AT LOCATIONS WHERE FRAMING IS LESS THAN 6'-0" IN LENGTH, CONTRACTOR MAY SUBSTITUTE REINFORCEMENT WITH FULL HEIGHT 2x4 SPF #2 OR BETTER. REINFORCEMENT TO BE SISTERED TO SIDE OF EXISTING STUDS PER NDS RECOMMENDATIONS.

4. CONTRACTOR TO CUT EXISTING BALLOON FRAMING STUDS AT FLOOR LINES AND INSTALL A CONTINUOUS DOUBLE PLATE ALONG EACH FLOOR LINE.
5. CONTRACTOR TO ATTACH WALL FRAMING TO FLOOR DIAPHRAGM AT OR BELOW EXISTING FLOOR LINE WITH FRAMING CLIPS.

6. CONTRACTOR TO INSTALL STRAP AND HOLD DOWNS FOR LATERAL WIND LOAD DISTRIBUTION PER 1/4.2. STRAP AND HOLD DOWN LOCATIONS TO BE ALIGNED. CONTRACTOR TO INSTALL ADDITIONAL REINFORCEMENT FRAMING AND BLOCKING AS REQUIRED TO ALIGN STRAPS AND HOLD DOWNS.

7. ALL EXTERIOR SHEATHING ON THE EAST ELEVATION TO BE REPLACED WITH 7/16" APA RATED EXTERIOR SHEATHING, ORIENTED VERTICALLY WITH HORIZONTAL JOINTS BLOCKED. PLYWOOD WALL PANELS SHALL BE ORIENTED WITH FACE GRAIN PARALLEL TO SUPPORT STUD.

8. REMOVE & REPLACE DAMAGED BATT INSULATION WITH MINERAL WOOL. COMPRESSION FIT ALL INSULATION. CONTRACTOR MAY SUBSTITUTE BATT INSULATION FOR MINERAL WOOL IF ALL CAPS AND VOIDS ARE FILLED. LIKELY VOID LOCATIONS ARE AT REINFORCEMENT LOCATIONS BETWEEN INTERIOR SHEATHING AND REINFORCEMENT MEMBER. CONTRACTOR TO PROVIDE WRITTEN NOTIFICATION OF SUBSTITUTION TO OWNER AND SHALL BE RESPONSIBLE FOR THE INSPECTION OF ALL VOIDS PRIOR TO BATT INSULATION INSTALLATION.

9. PERFORM VAPOR BARRIER REPAIRS WHERE CUTS, TEARS, AND VOIDS ARE PRESENT. IT IS RECOMMENDED THAT THE CONTRACTOR INSPECT ALL VAPOR BARRIER APPLICATIONS PRIOR TO INSULATING WALL.
10. IF CONDITIONS ARE DISCOVERED THAT VARY FROM THOSE REPRESENTED HEREIN, CONTRACTOR TO NOTIFY ENGINEER PRIOR TO PROCEEDING.
11. SEE ELEVATION DRAWINGS, DETAILS, AND SUMMARY OF WORK FOR ADDITIONS. INFORMATION.

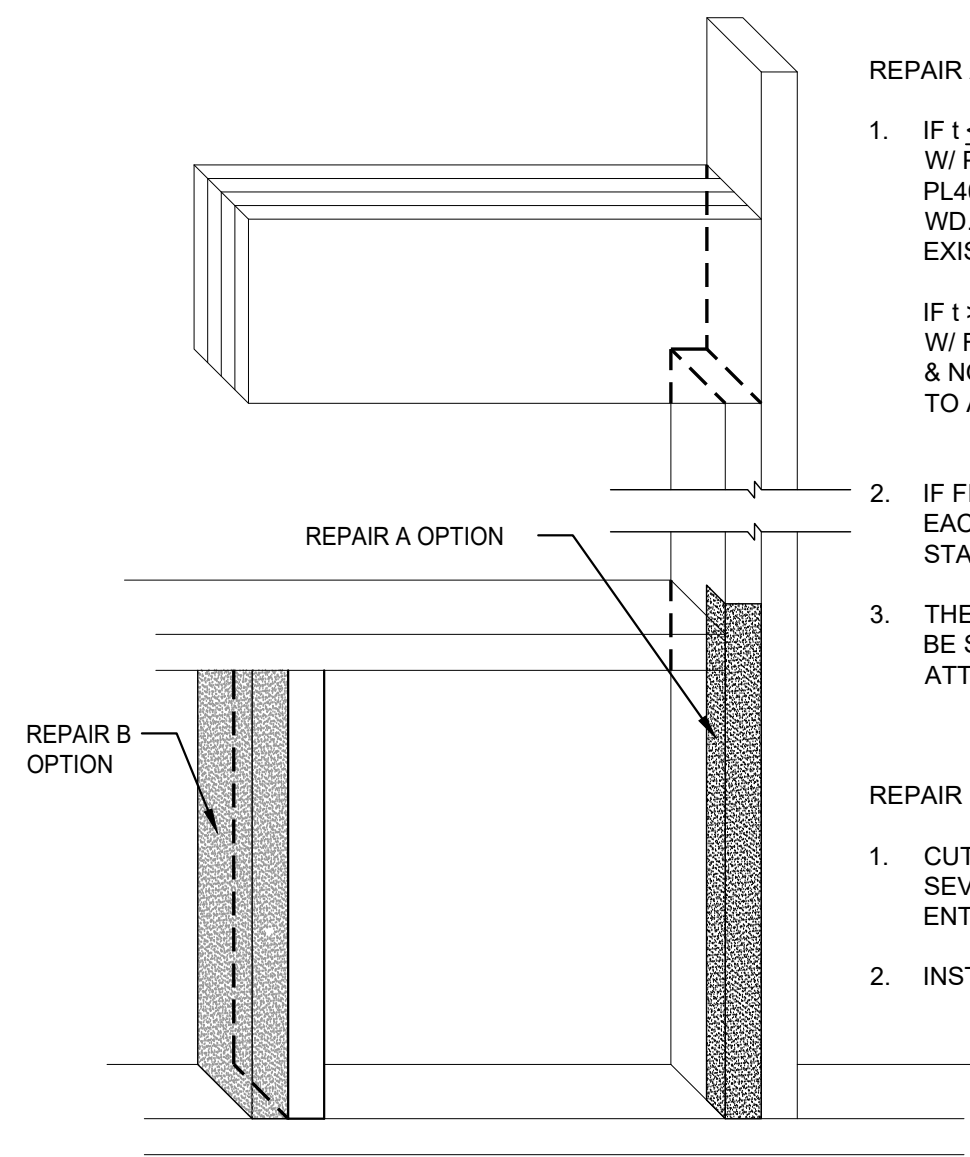
1 STUD REPAIR/REPLACEMENT DETAIL
SCALE: NTS

NOTE:
EXISTING STUD AND FRAMING CONDITIONS LIKELY VARY BY LOCATION.

- REPAIR A) NOTCHING**
- IF $t < 1.0"$, REMOVE DAMAGED AREAS & REPLACE W/ PIECES OF 1/2" THICK PLYWD. STRIPS. USE PL400 CONST. ADHESV. & NO. 10 X 3 1/2" LONG WD. SCREWS @ 12" O.C. TO ATTACH PLYWD. TO EXIST. STUD.
 - IF $t > 1.0"$, REMOVE DAMAGED AREA & REPLACE W/ RIPPED 2X STUD. USE PL400 CONST. ADHESV. & NO. 10 X 3 1/2" LONG WD. SCREWS @ 12" O.C. TO ATTACH NEW 2X STUD TO EXIST. STUD.
- REPAIR B) SISTERING-WHERE ROT EXTENDS > 2" DEEP**
- CUT OUT DAMAGED PORTION OF STUD OR IF SEVERELY DETERIORATED, REMOVE STUD ENTIRELY.
 - INSTALL NEW STUD NEXT TO ORIGINAL

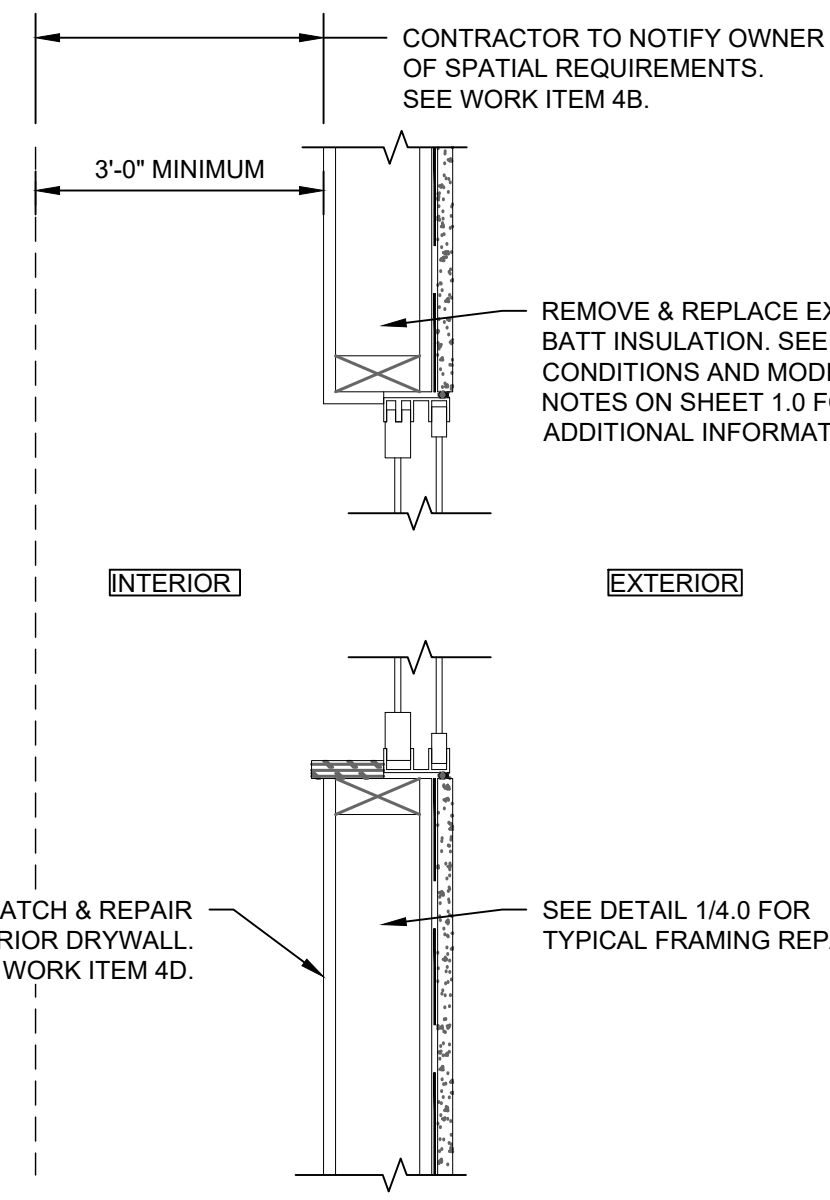
1 DEMOLITION - TYPICAL STUCCO
4.1 SCALE: 1" = 1'-0"

- NOTES:**
1. SUBSTANTIAL AND SIGNIFICANT FRAMING DAMAGES ARE SUSPECTED BEHIND STUCCO. CONTRACTOR TO INSTALL TEMPORARY SHORING AND BRACING AS NEEDED.
 2. CONTRACTOR TO PROVIDE TEMPORARY SAFETY BARRICADES TO SEPARATE THE LIVING SPACE FROM THE WORK ZONE.
 3. SEE DETAIL 24.1 FOR ADDITIONAL INFORMATION.

REMOVE & REPLACE DAMAGED WALL FRAMING, BLOCKING, AND SHEATHING. PARTIALLY CUT AND REMOVE INTERIOR DRYWALL AS NEEDED.

REMOVE & REPLACE EXISTING WINDOWS.

REMOVE & DISPOSE OF ALL STUCCO, FELT PAPER, AND EXTERIOR SHEATHING. SEE ELEVATIONS FOR ADDITIONAL INFORMATION.
