April 26, 2021

RE: Microbial Consulting
Cityview Cooperative
1801 – 1817 Elliot Avenue, Minneapolis, MN
April 23rd Site Visit
LEGEND No. 21-1809

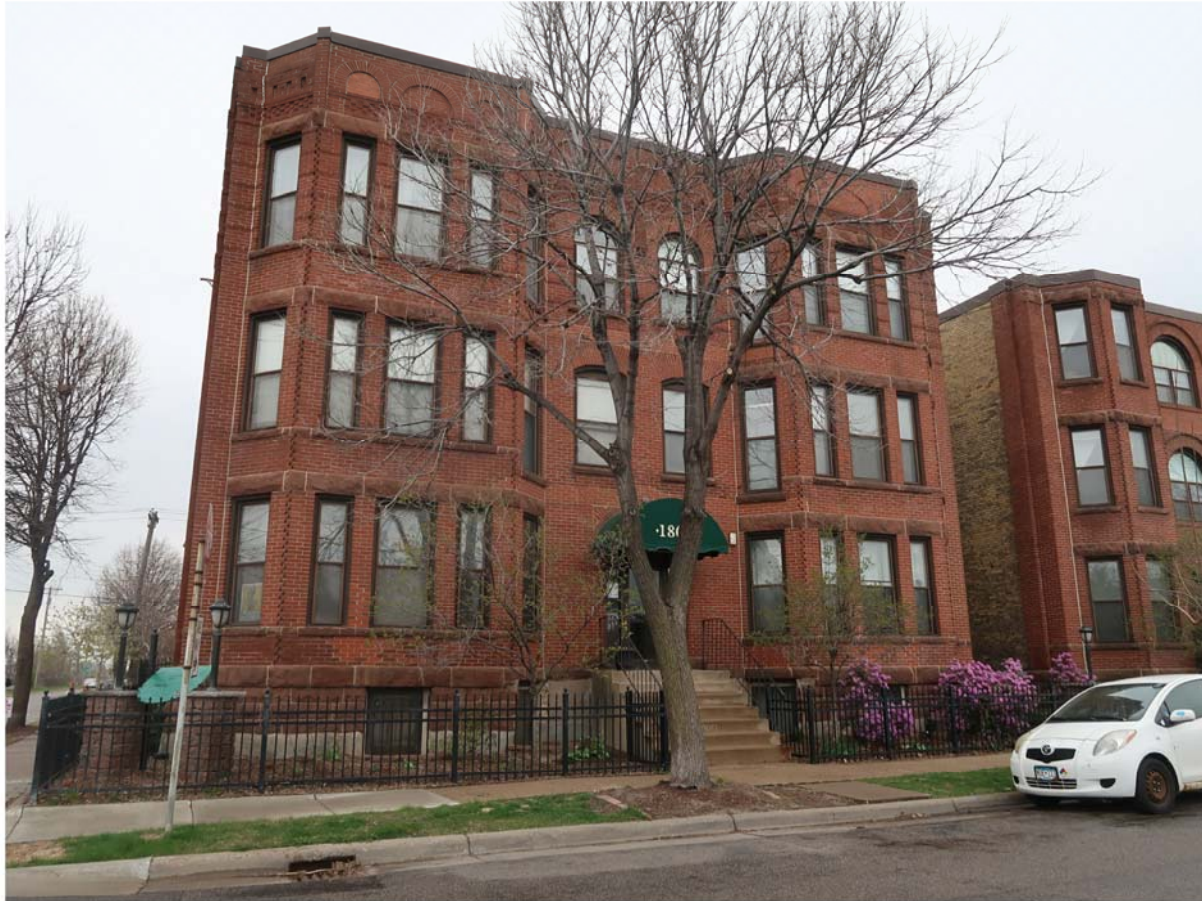
Photo 1 - Elliot Street Front Face of the Building

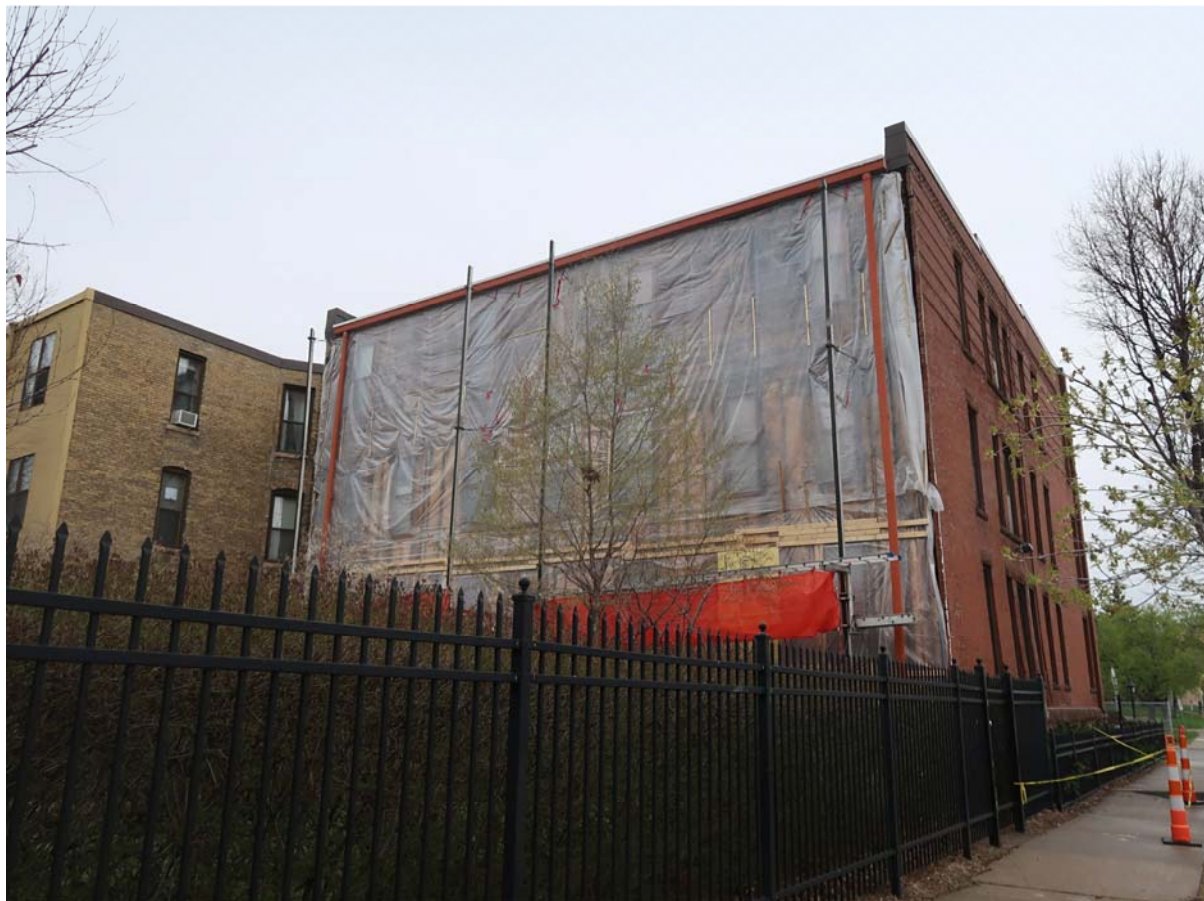
Photo 2 - Rear of the Building

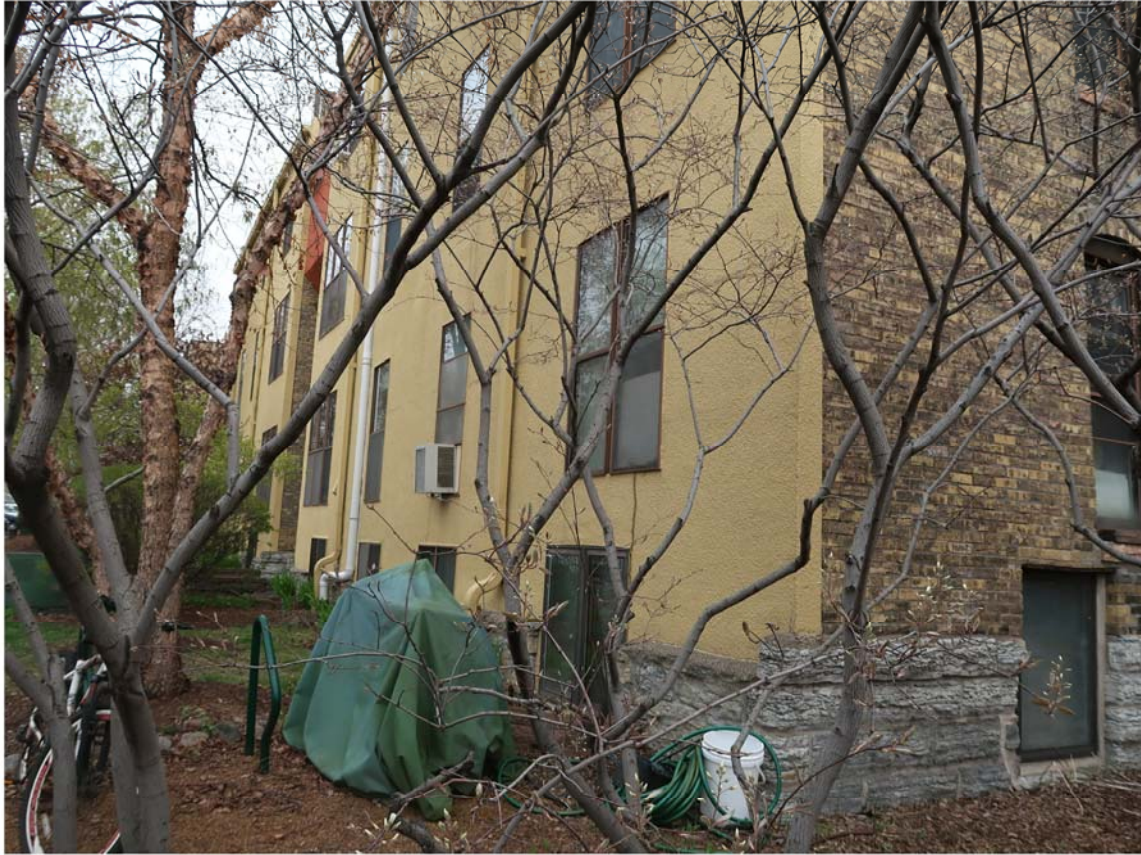
Photo 3 - Stucco Was On the 1801 Building Similar to the Next Door 1809 Bldg

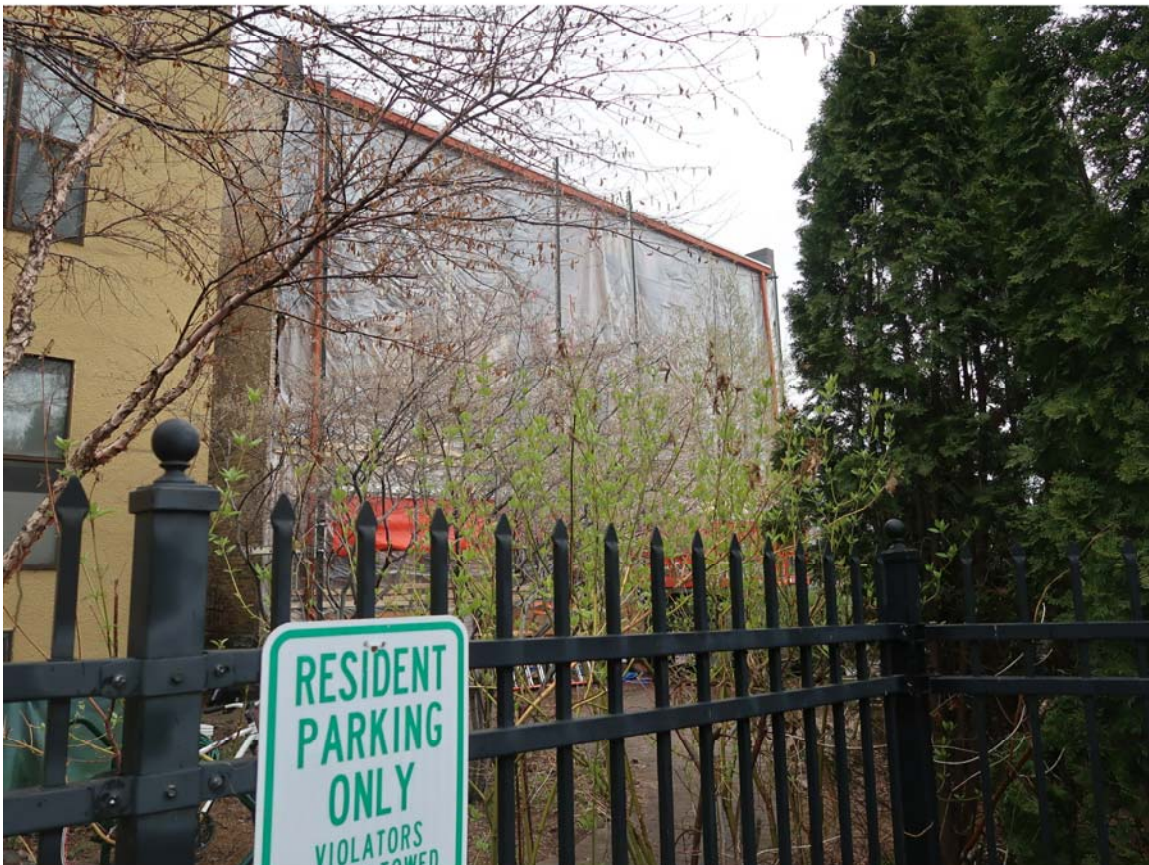
Photo 4 - Rear Showing 1801 and 1809 Buildings

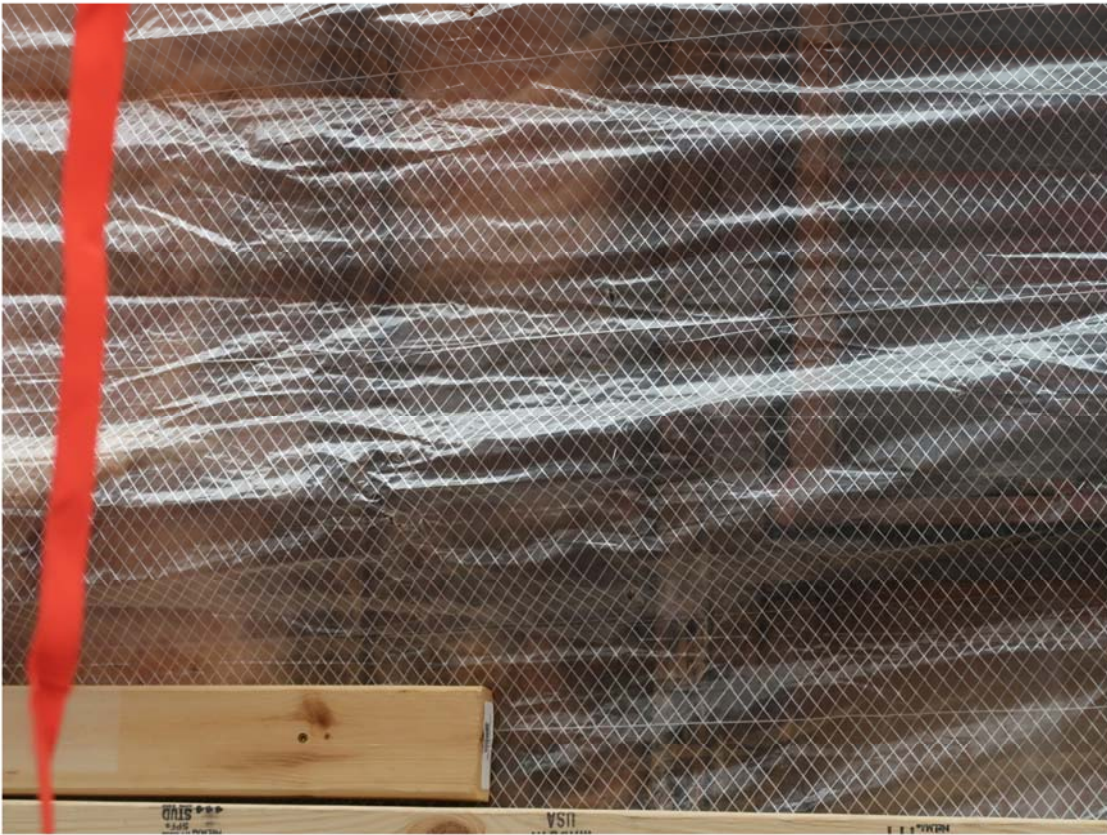
Cheryl A Sykora, CIH, CSP, CHMM visited the project in the morning of April 23, 2021. At that time the stucco had already been removed from the rear of 1801-1803 and the exposed cavity was covered over with reinforced polyethylene sheeting. LEGEND received photographs of the exposed framework previous to the site visit and did not request opening the sheeting to the rain.

Photo 5 - Close up of Polyethylene Covered Opened Exterior Wall

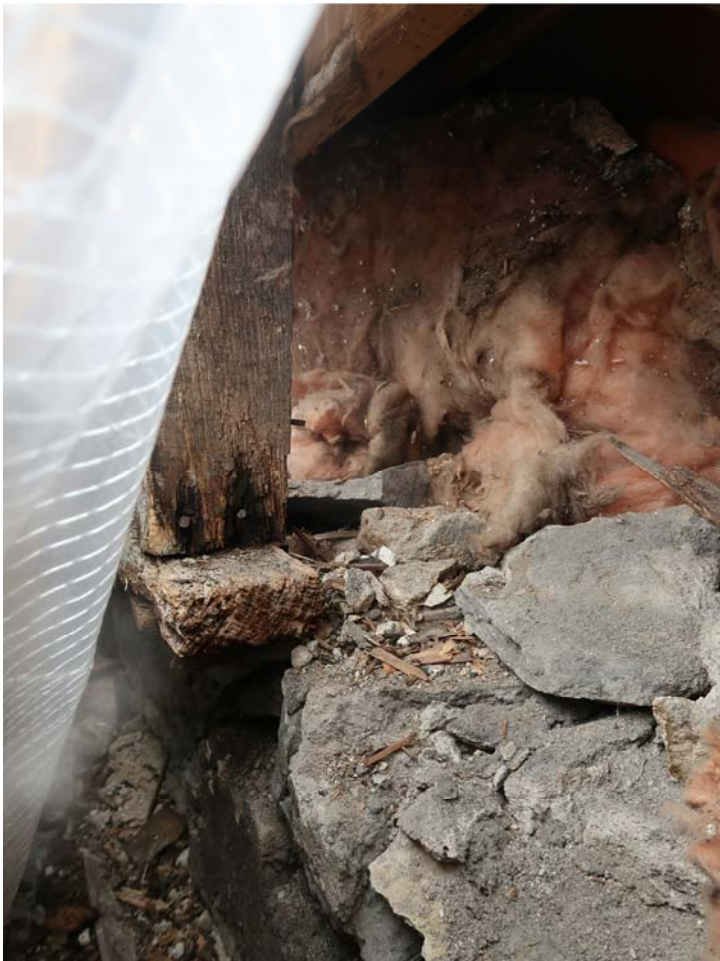
The plan for replacing structurally marginal wood was discussed with Justin Hamm. It was identified that most wood was structurally sound and additional wood would be added where there were issues with the framework. The framework, itself, appears to be original to the building based on appearance. The darkness in the wood is from the vintage and not an indication of rot conditions as it would be in more recently installed wood. Mr. Hamm stated that some wood is suspected to have been replaced in the 1980s when the major renovation took place and wood replacement was not expected to be significant.

Photo 6 - Looking Inside the Wall Cavity

Recommendations were discussed with Mr. Hamm. LEGEND prefers a hydrogen peroxide-based disinfectant because it is effective and non-corrosive. Specific brand is a determination Atlas can make. Safety Data Sheet (SDS) will be available for the product as it is regulatory mandated to be available and should be provided to responsible cooperative members for reference. Exposure to the hydrogen peroxide is limited to workers directly applying the material and not to the occupants. Biocides are highly reactive chemicals and do not create a residual exposure concern. The applied strength is usually around 3 - 5% and two applications of a weaker strength solution is more effective than one application of a stronger solution. This can be applied where significant wood disintegration and/or visible mold are noted. The structural wood in this building is denser than newer construction. Application of an anti-fungal paint (generally are white and contain zinc oxide) is optional in LEGEND's opinion. It is assumed that the renovation will make the building less prone to water retention and wood rot so anti-fungal paint would be more cosmetic than a needed step in this situation.

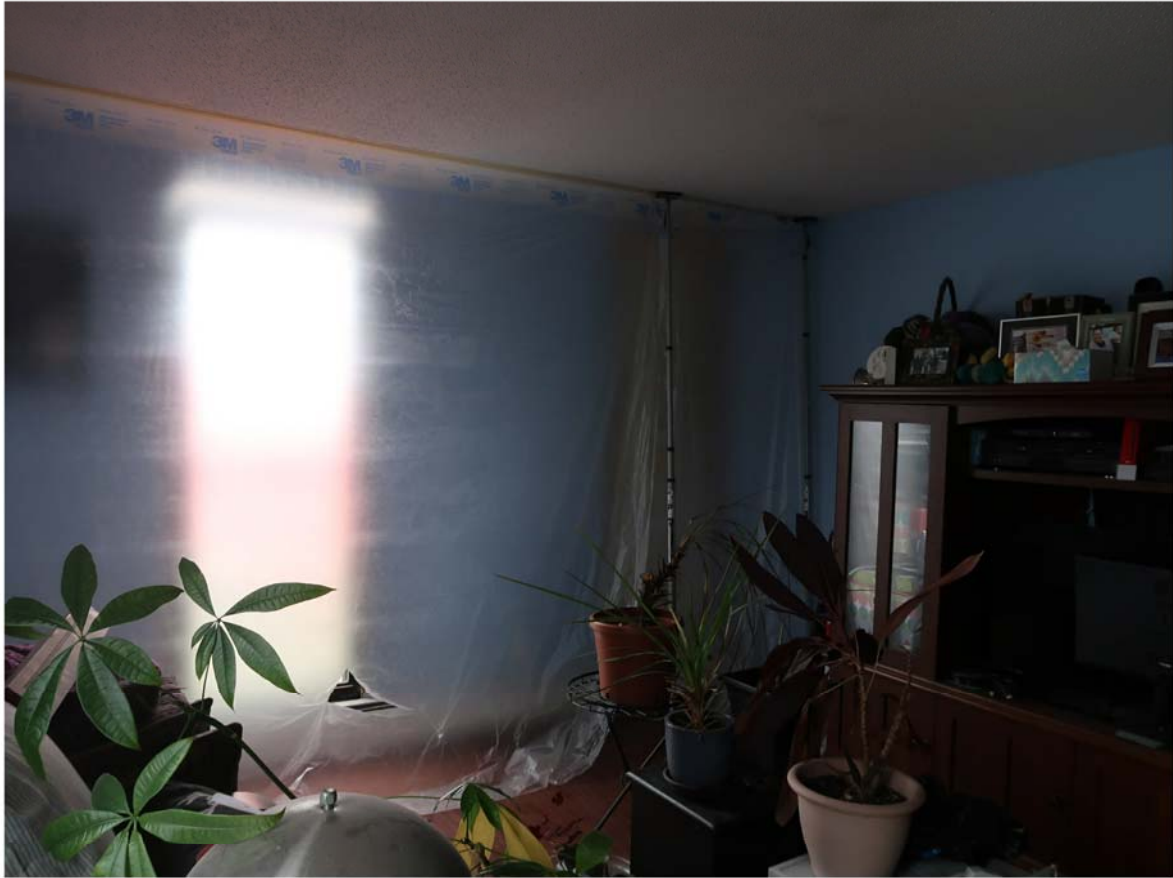
Unit 5 inside building 1801-1803 was empty (owner was out of town) and that unit was viewed. The exterior wall had been sheeted off with 2 mil polyethylene sheeting using portable supports for enclosure construction. Inside the poly sheeting, the window trim was removed and one

window had plywood in it. The exterior inside wall was observed to be gypsum wallboard with a full skim coat over the GWB. The window wells were observed to be wide, especially on the below grade level. The GWB appeared to be structurally sound around the window and visible fungal growth was either not present or minimal.

Photo 7 - Unit 5 Exterior Wall Where Window Work Will Be Done

The interior enclosure needs to be more of a containment than a barrier. If Unit #5 is representative of all units, there is substantial furnishings that can be impacted with renovation dust and the enclosure will serve to both control fugitive dust and fungal spore dispersal to the inside of the unit. Conditions are hidden and it is possible, more extreme conditions could be encountered than what was observed in Unit #5. It was suggested that the enclosure include a recirculating small HEPA filtered unit to capture dust as it is generated. A tack mat outside the enclosure would control transfer of dust outside the enclosure. This is a minimum containment but should be sufficient to control fungal spore and dust exposure to the occupants during the interior work. If no interior work is done, the outside work would require no special enclosure inside the building.
