# Town Course Heights Heritage Townhome Association

**Moisture Intrusion Issue**

# Backstory

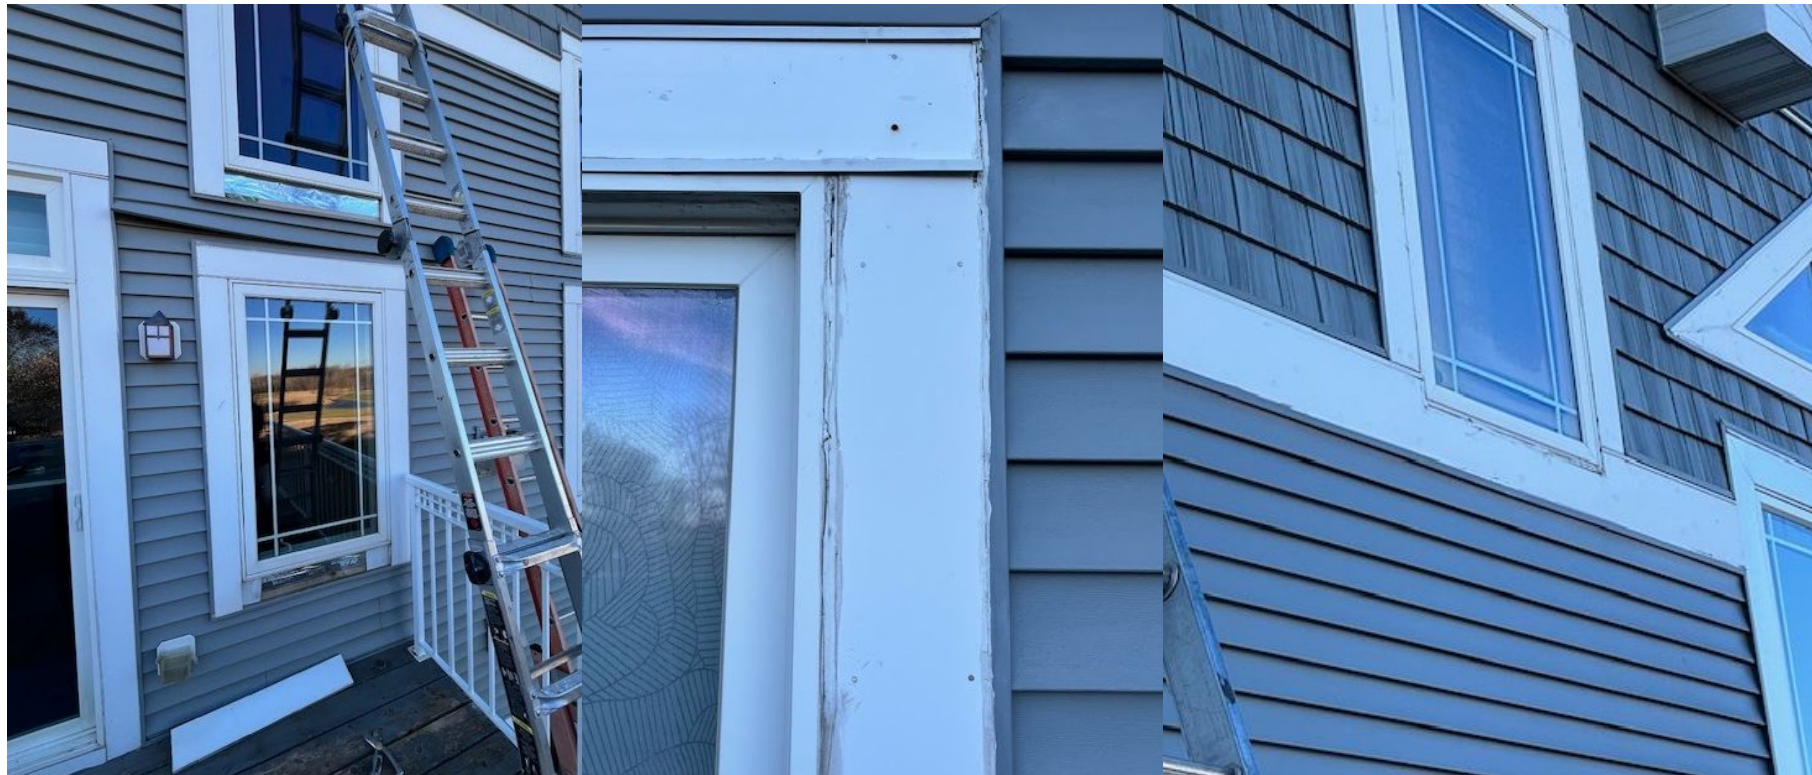
# PVC Belly Band and Window/Door Trim

A tech was dispatched to the community and the PVC belly band and trim around the windows were inspected and believed to be the source of the water intrusion as well as missing deck ledger board flashing.

While on-site we noticed multiple layers of caulking had been applied to the seems and transitions of PVC trim in the areas of the leak. This was another companies previous attempt to address the issue.

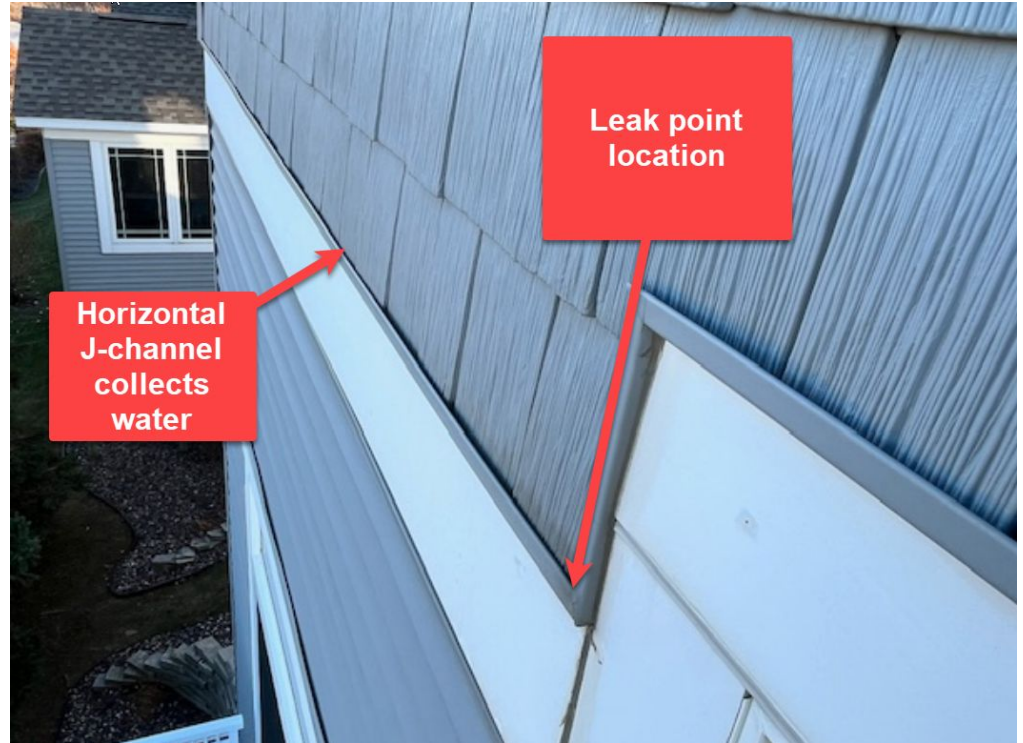
# Collecting water & leak points

On the top side of the belly band a piece of J-channel was installed to hold the first row of shake siding. This J-channel collects water and has to find a way out. Where the J-channel butts into the window trim is an ideal location for water to get behind the siding and begin the path of getting behind the moisture barrier.

In place of the J-channel that collects water on the top side of the belly band, a starter fastening strip will be installed to hold the bottom row of shake siding. This will eliminate the channel that holds water and exits at the seams and corners.

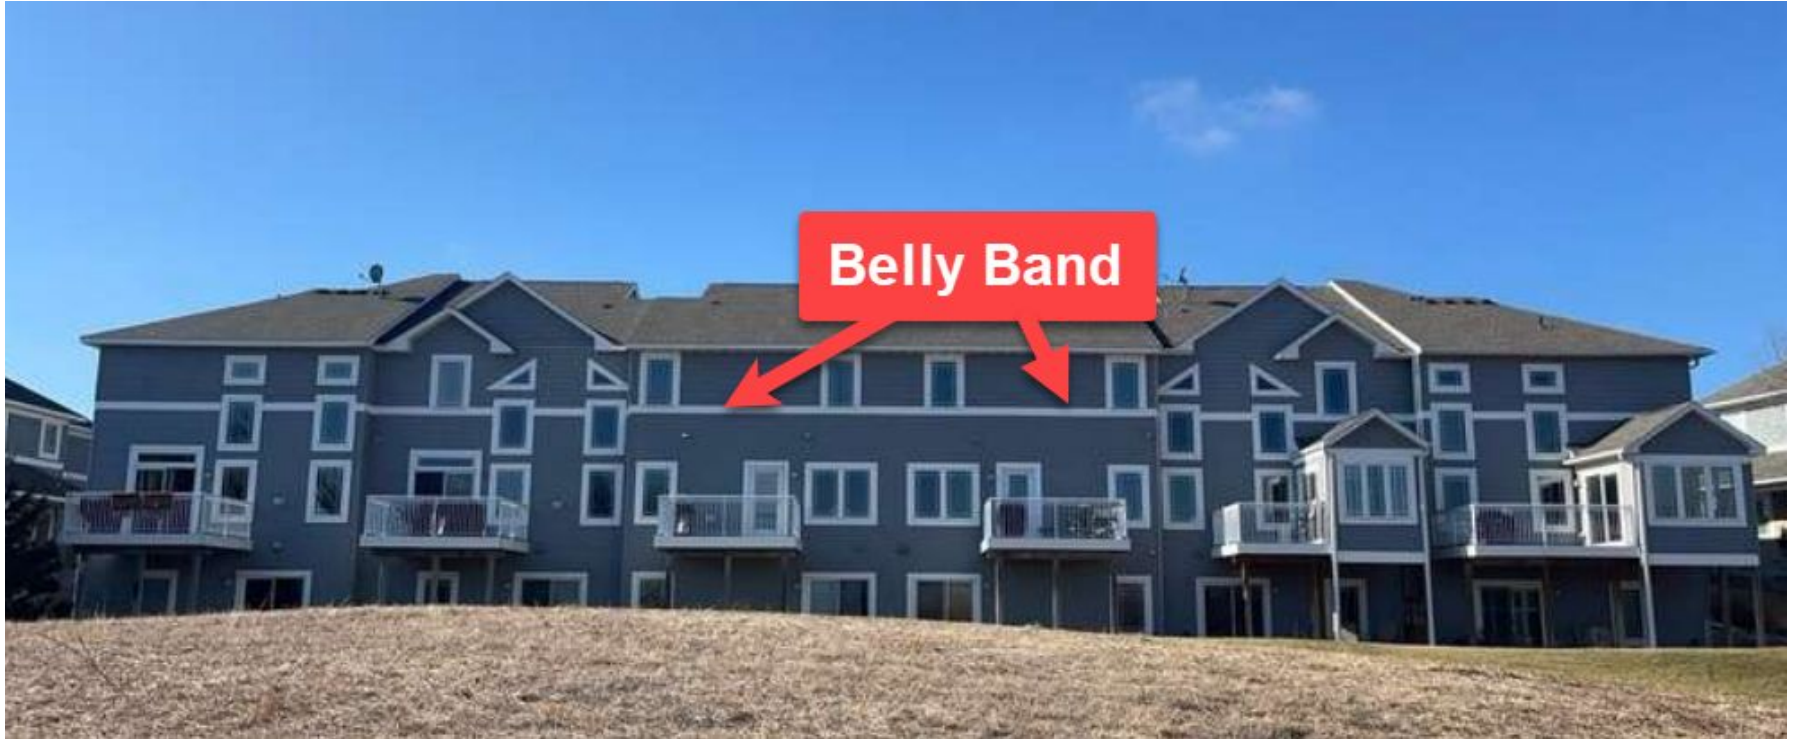
# Back elevation belly band

The belly band is a 1"x 8" PVC trim board and is not a typical vinyl siding accessory. The same materials were used to trim around the windows and doors for aesthetics. The belly band was installed in a location that intersects with the most of the upper windows and was notched as needed to fit around the frame of the window.

This horizontal surface collects water and it eventually finds its way behind the moisture barrier where the belly band meets the vertical window trim. It's a small amount of water but over time it led to severe rot to the exterior sheathing and in some cases the structural framing.

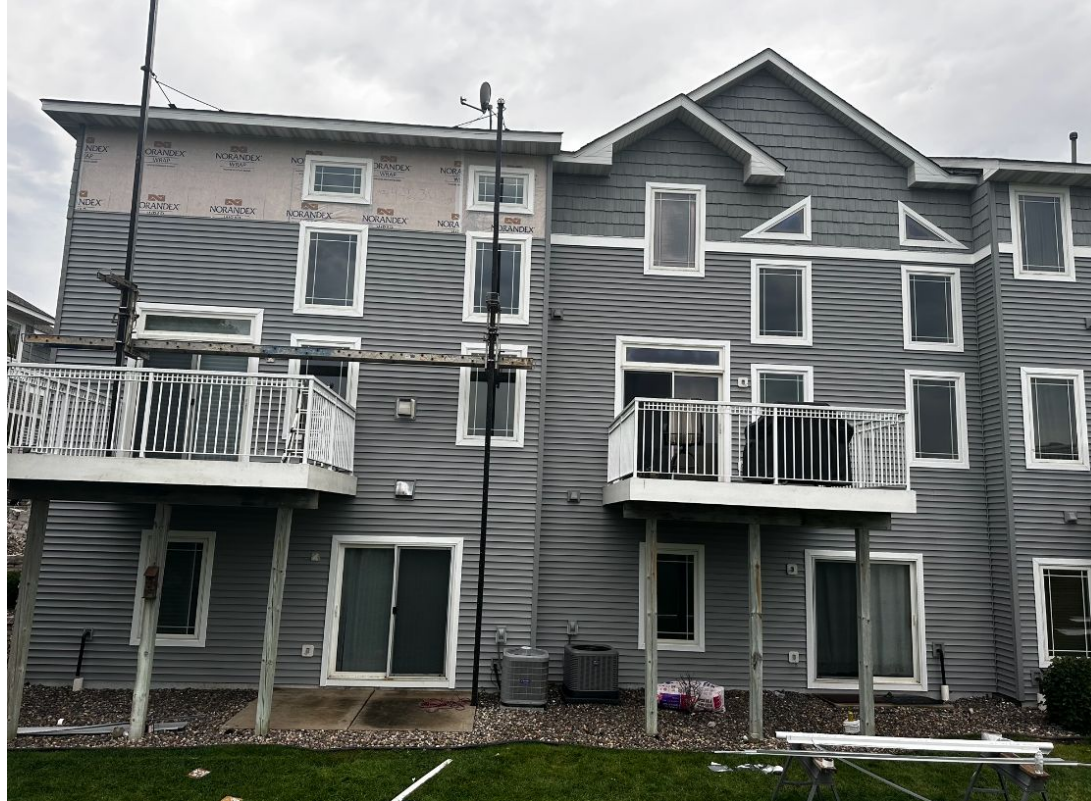
# Belly Band Location Change

In the spring of 2024 the Board of Directors approved the recommended scope of work to remove and replace the moisture barrier and vinyl siding on the back elevation and install a belly band and window/door trim that is used with vinyl siding. The location of the belly band was also changed to limit the need to notch it around the windows.

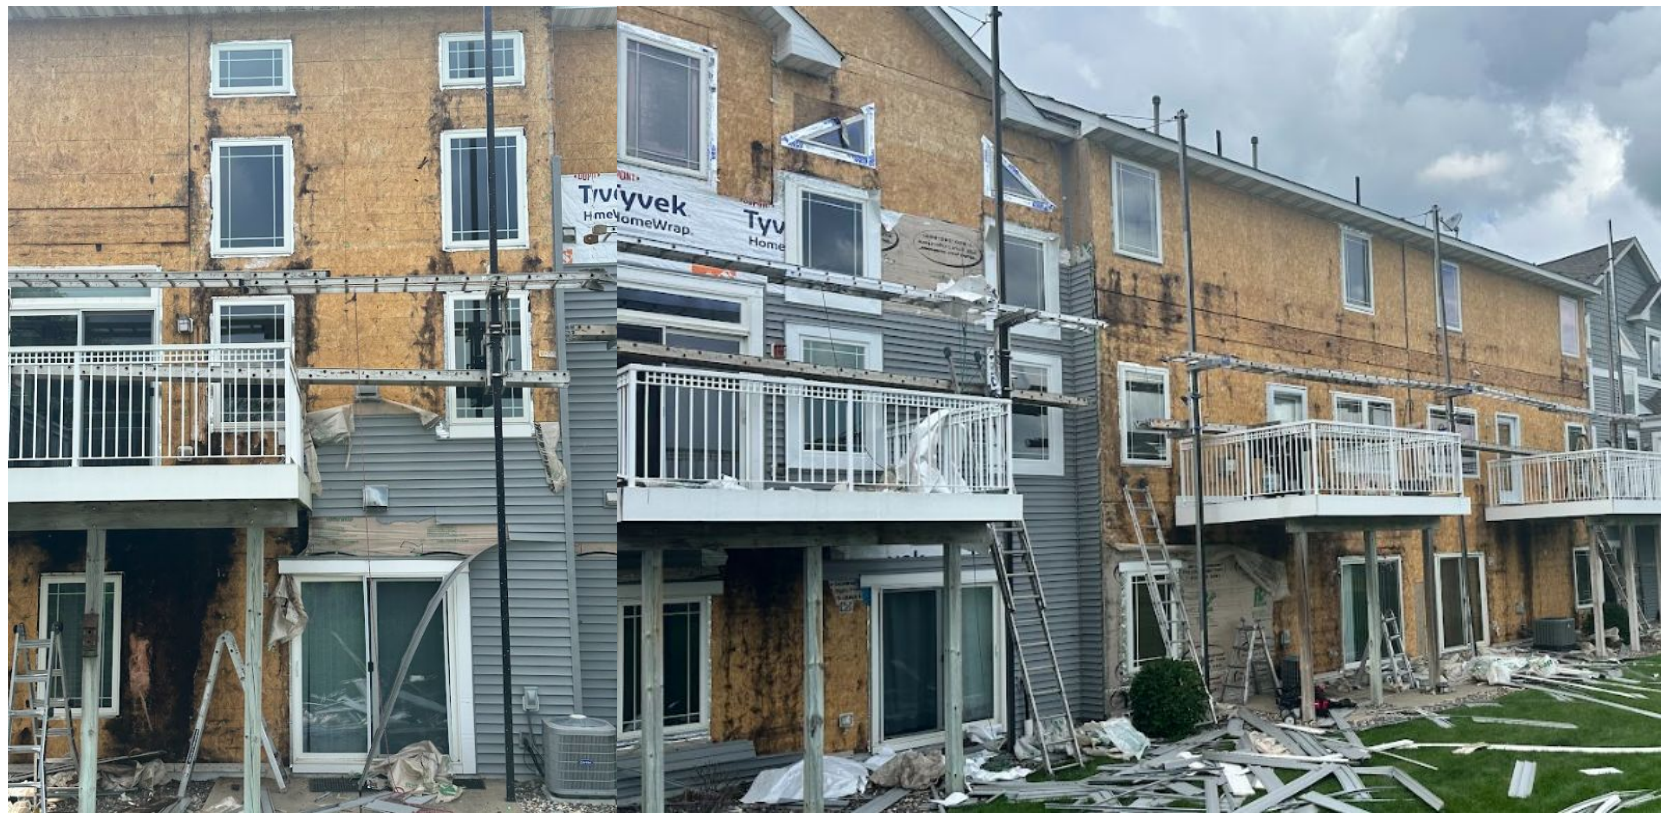
# Sheathing Rot Photos

After removing the siding and moisture barrier the extent of the rot was exposed. In select locations, the moisture had completely rotted the exterior sheathing and portions of the structural framing. As part of the work, all rotted sheathing and framing was cut out and replaced before installing the new moisture barrier and siding.

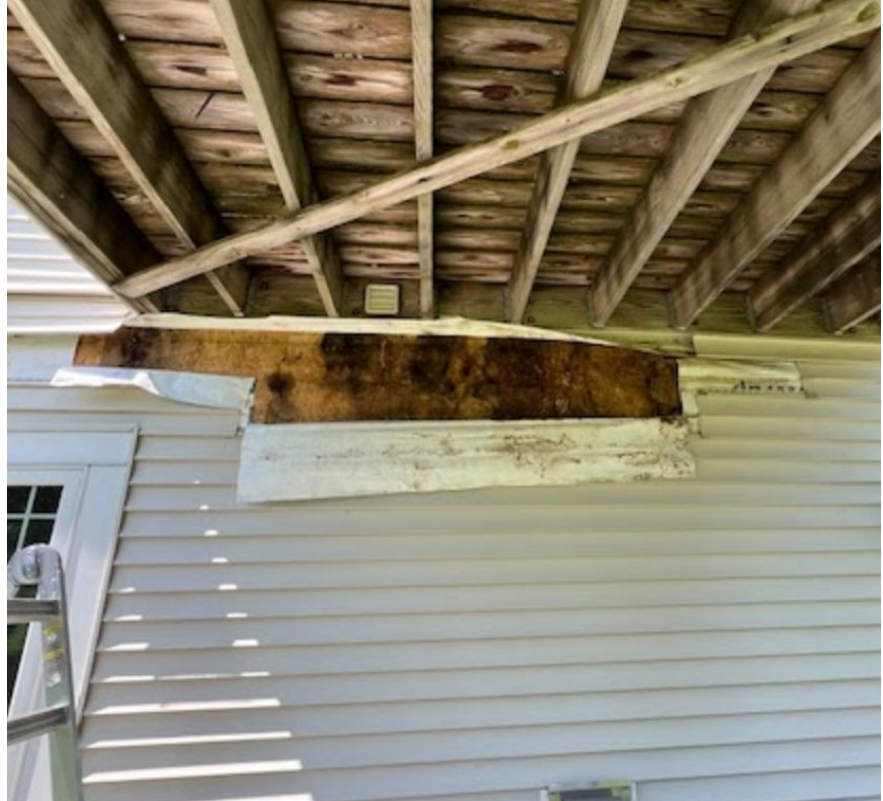
# Missing Deck Ledger Board Flashing

On select decks the appropriate ledger board flashing was not installed. This was and is allowing moisture to get behind the moisture barrier and cause rot to the sheathing. As part of the project all decks were inspected and ledger flashing was installed to those that did not have it installed.

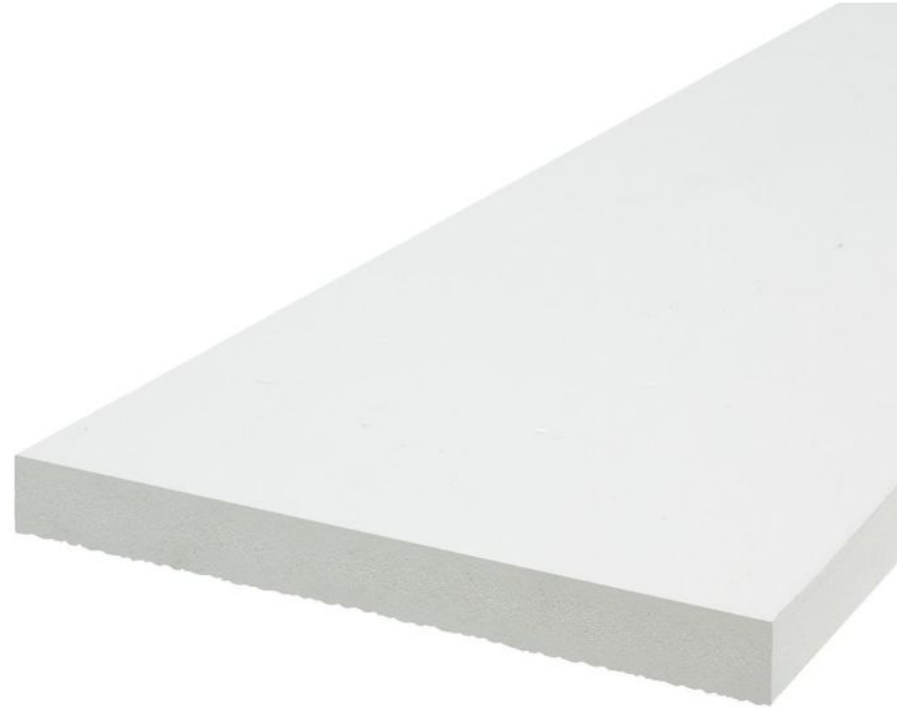
# Current Trim Boards and Belly Band

The current belly band, window and door trim is a dimensional PVC trim board that is not typically integrated with vinyl siding. The product is a quality, low maintenance material but does not include a hidden nail strip and channel to receive and hide the cut edge on the siding and requires a separate J-channel.
