2021 EXTERIOR FACADE REPAIR PROJECT: PHASE I

CITYVIEW CO-OP
1801 ELLIOT AVENUE SOUTH
MINNEAPOLIS, MN

DRAWING INDEX

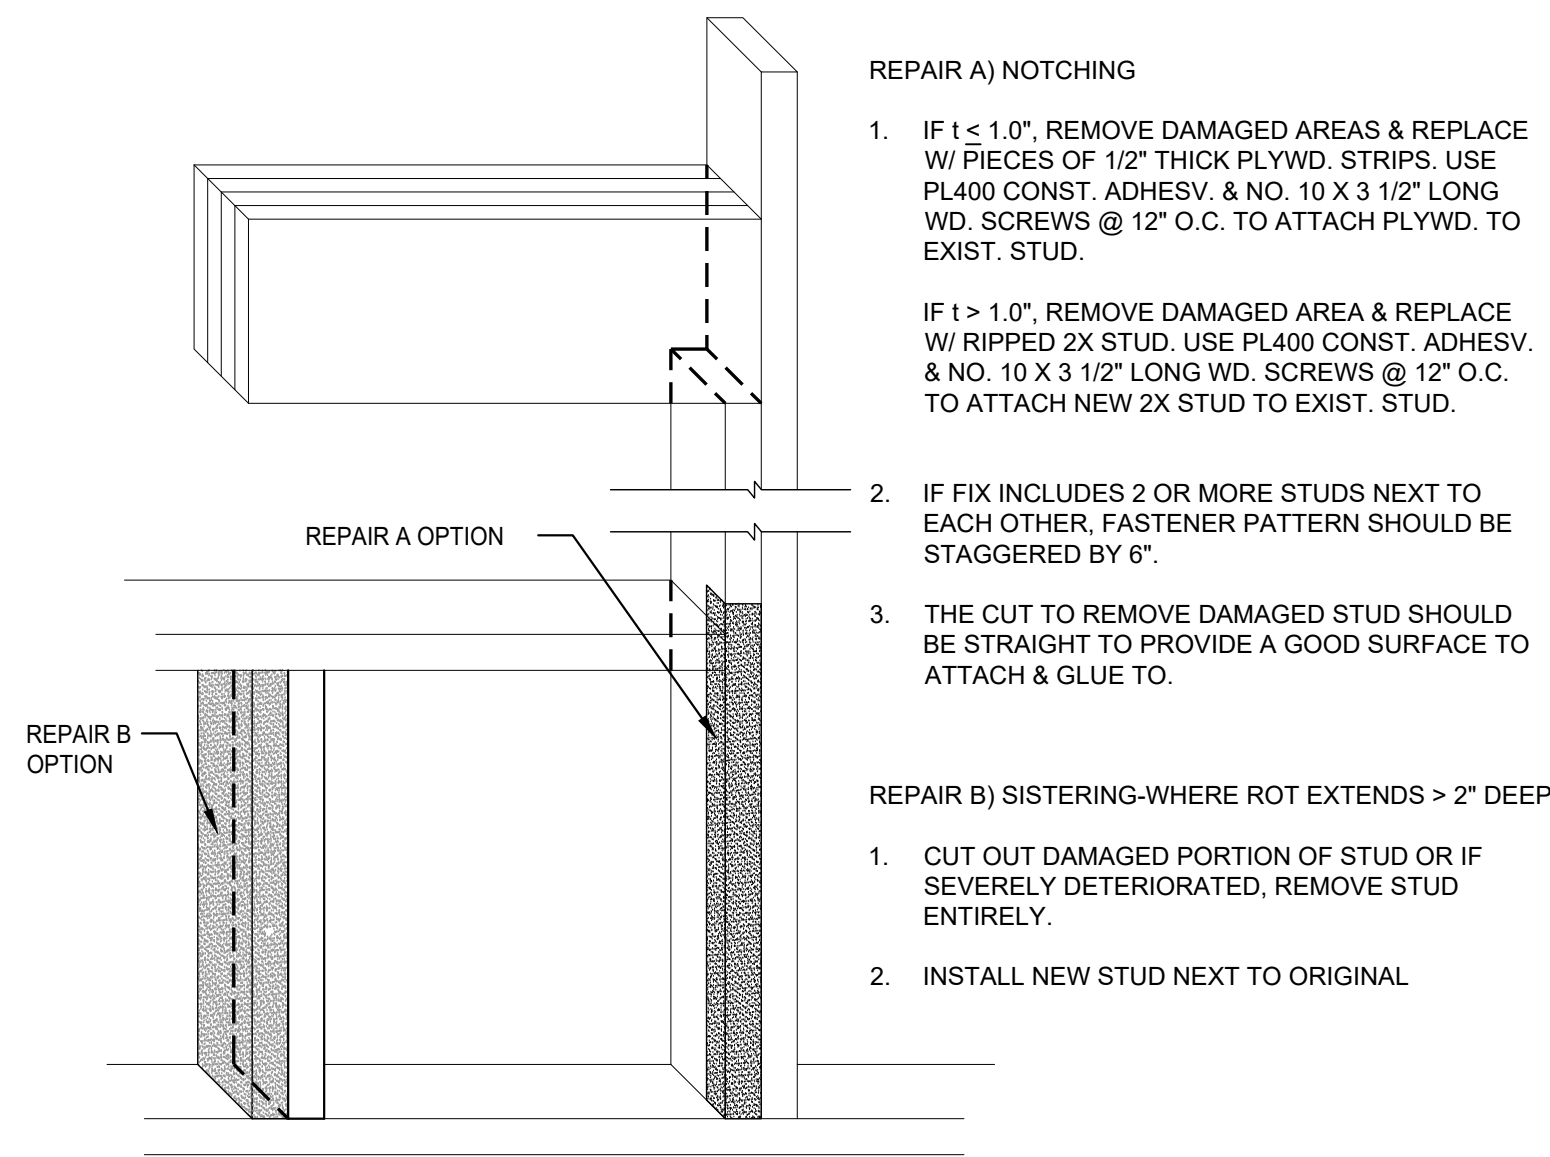
1 STUD REPAIR/REPLACEMENT DETAIL
SCALE: NTS

NOTE:
EXISTING STUD AND FRAMING CONDITIONS LIKELY VARY BY LOCATION.

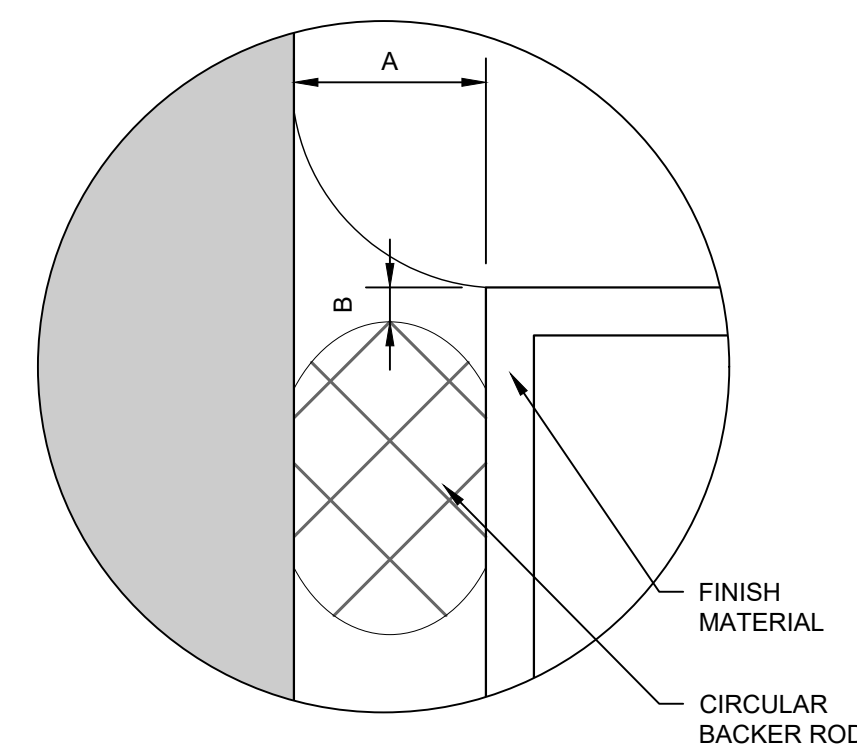
7 TYP. SEALANT JOINT PROFILE
SCALE: 1'-0" = 1'-0"

- NOTES:**
- RATIO A-B SHALL BE 2:1
 - "A" DIMENSION SHALL BE 1" MAX.
 - "B" DIMENSION SHALL BE 1/4" MIN. U.N.O.

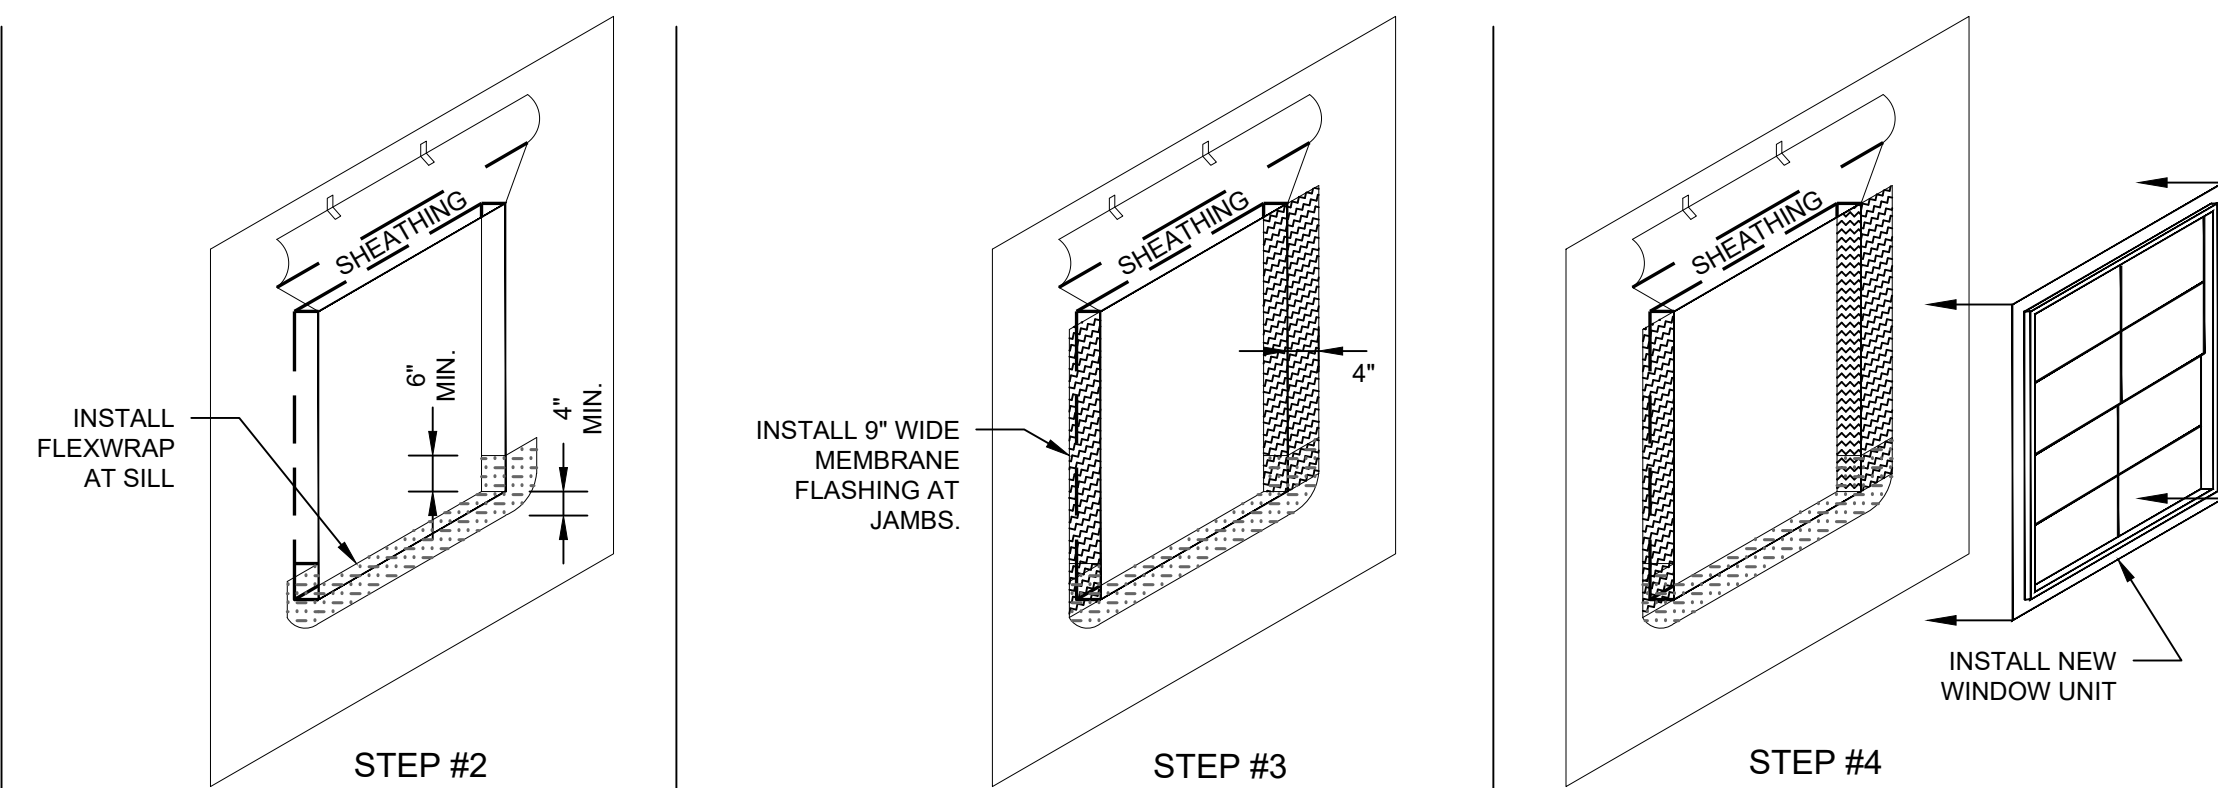
2 WINDOW REPLACEMENT FLASHING DETAIL
SCALE: 3/8" = 1'-0"

- NOTES:**
- LAP FLEXWRAP 6" UP JAMBS
 - LAP OVER WEATHER BARRIER 4" MIN
 - EXTEND INTO ROUGH OPENING FULL DEPTH OF FRAMING
- NOTES:**
- LAP MEMBRANE FLASHING OVER FLEXWRAP
 - EXTEND INTO ROUGH OPENING THE FULL DEPTH OF FRAMING
 - EXTEND ONTO WALL OVER WEATHER BARRIER 4" MIN.
 - APPLY SEALANT TO ANY EXPOSED EDGES OF FLEXWRAP THAT EXTEND BEYOND JAMB FLASHING

4. ALL WEATHER BARRIER AND ROUGH OPENING FLASHINGS TO BE SHINGLE LAPPED. SEE DETAIL 21.0 FOR TYPICAL WEATHER BARRIER AND FLASHING INSTALLATIONS AT WINDOW REPLACEMENT LOCATIONS. SEE SECTION DETAILS FOR ADDITIONAL INFORMATION. ALL SILL FLASHING TO BE INSTALLED WITH AN UPTURNED LEG TO PREVENT INCIDENTAL WATER DRAINING TOWARDS THE INTERIORS. THIS UPTURNED LEG TO BE BETWEEN THE WINDOW FRAME AND THE EXTENSION JAMB (ALONG THE SILL). THE SILL FLASHING SHALL BE A NON-CONDUCTIVE MATERIAL, SUCH AS TYVEK FLEX WRAP.

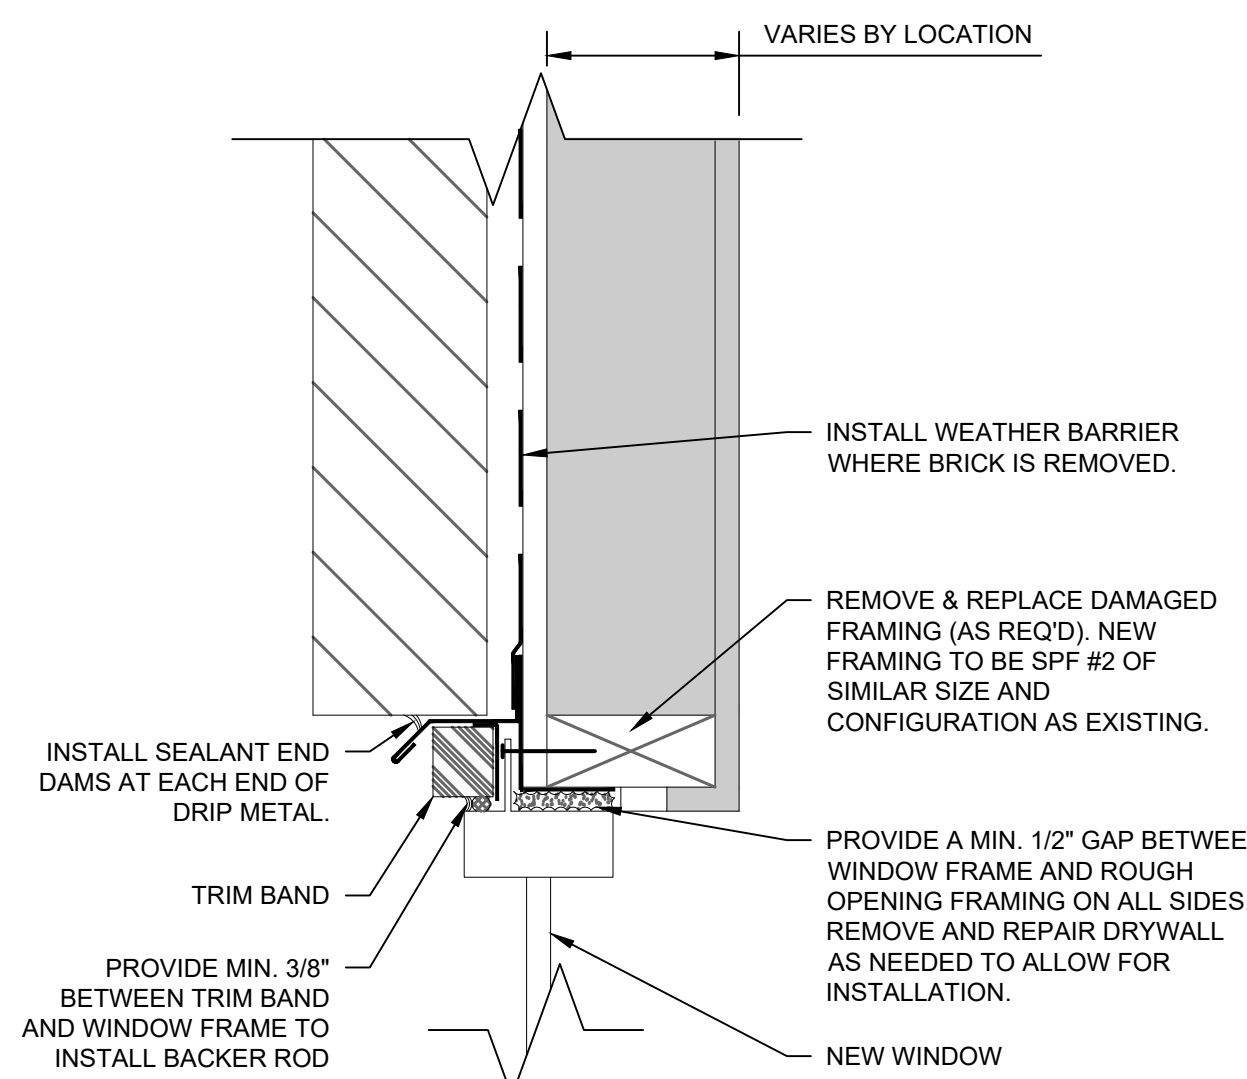
10 HEAD REPAIR (BRICK REMOVED)
SCALE: 3" = 1'-0"

SEE DETAIL 11/4.0 FOR SIMILAR INSTALLATION REQUIREMENTS.

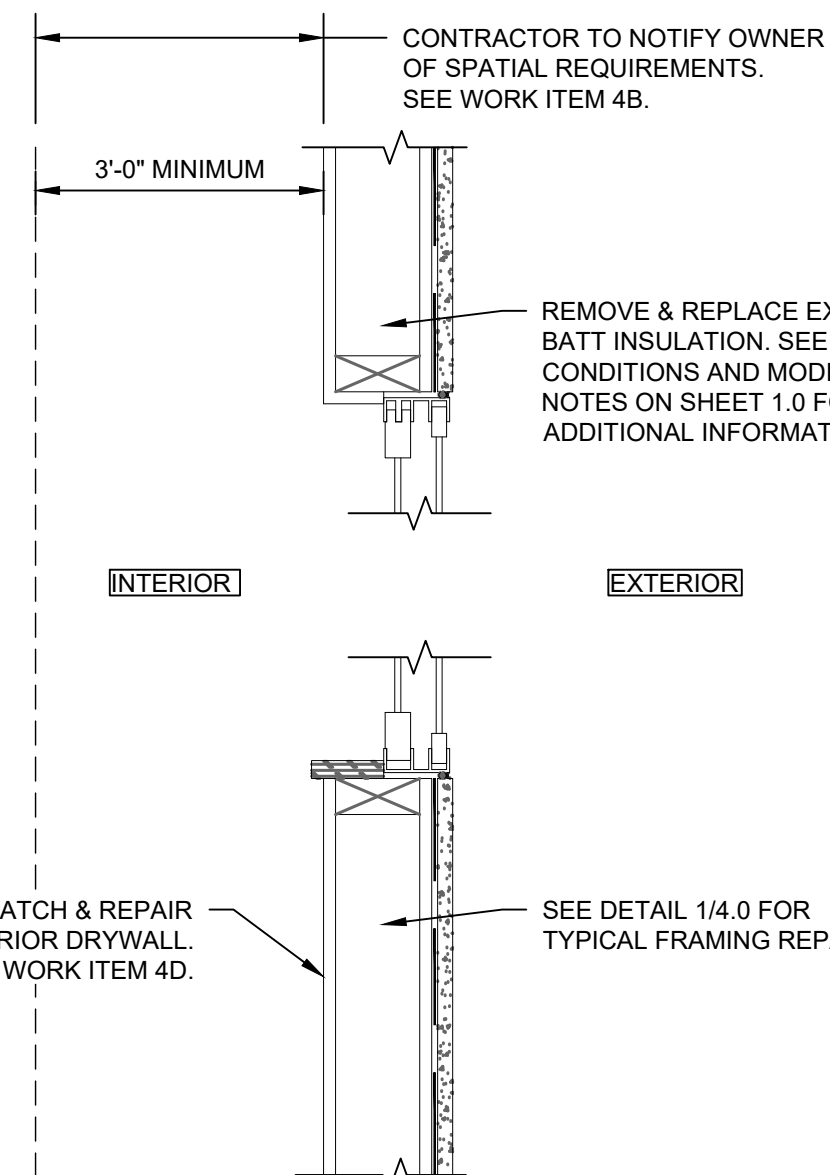
2 ADDITIONAL DEMO AND REPAIR NOTES (EAST ELEVATIONS)
4.1 SCALE: 1 1/2" = 1'-0"

1. SUBSTANTIAL AND SIGNIFICANT FRAMING DAMAGES ARE SUSPECTED BEHIND STUCCO. CONTRACTOR TO INSTALL TEMPORARY SHORING AND BRACING AS NEEDED.
2. CONTRACTOR TO PROVIDE TEMPORARY SAFETY BARRICADES TO SEPARATE THE LIVING SPACE FROM THE WORK ZONE.
3. SEE DETAIL 24.1 FOR ADDITIONAL INFORMATION.

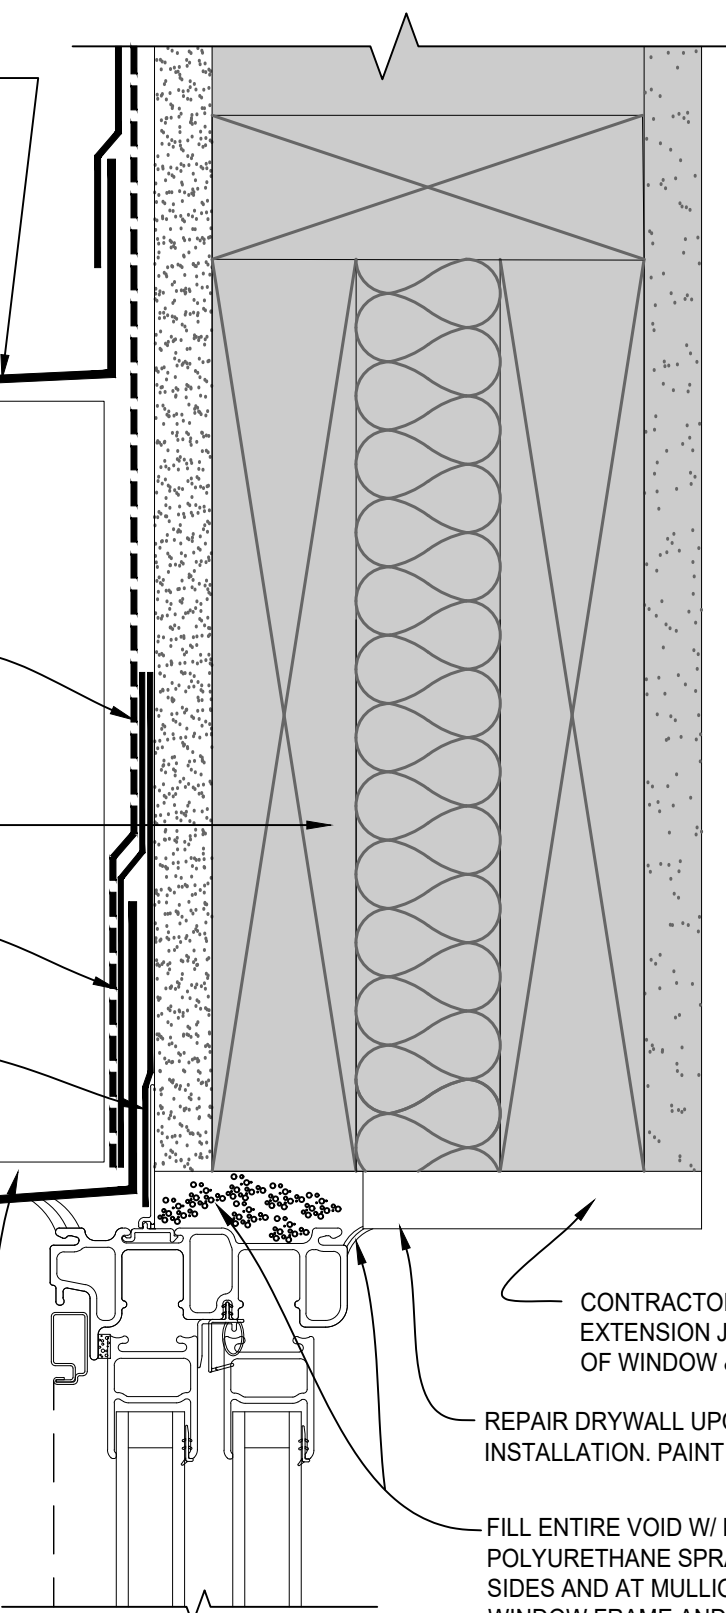
3 TYP. WINDOW HEAD DETAIL WHERE WINDOW IS REPLACED (SIDING)
4.1 SCALE: 6" = 1'-0"

INSTALL Z-FLASHING AND TAPE TO WEATHER BARRIER PER MANUFACTURER RECOMMENDATIONS OR SHINGLE LAP WITH WEATHER BARRIER.

INSTALL MEMBRANE FLASHING OVER NAILING FLANGE

INSTALL SEALANT END DAM AT BOTH ENDS

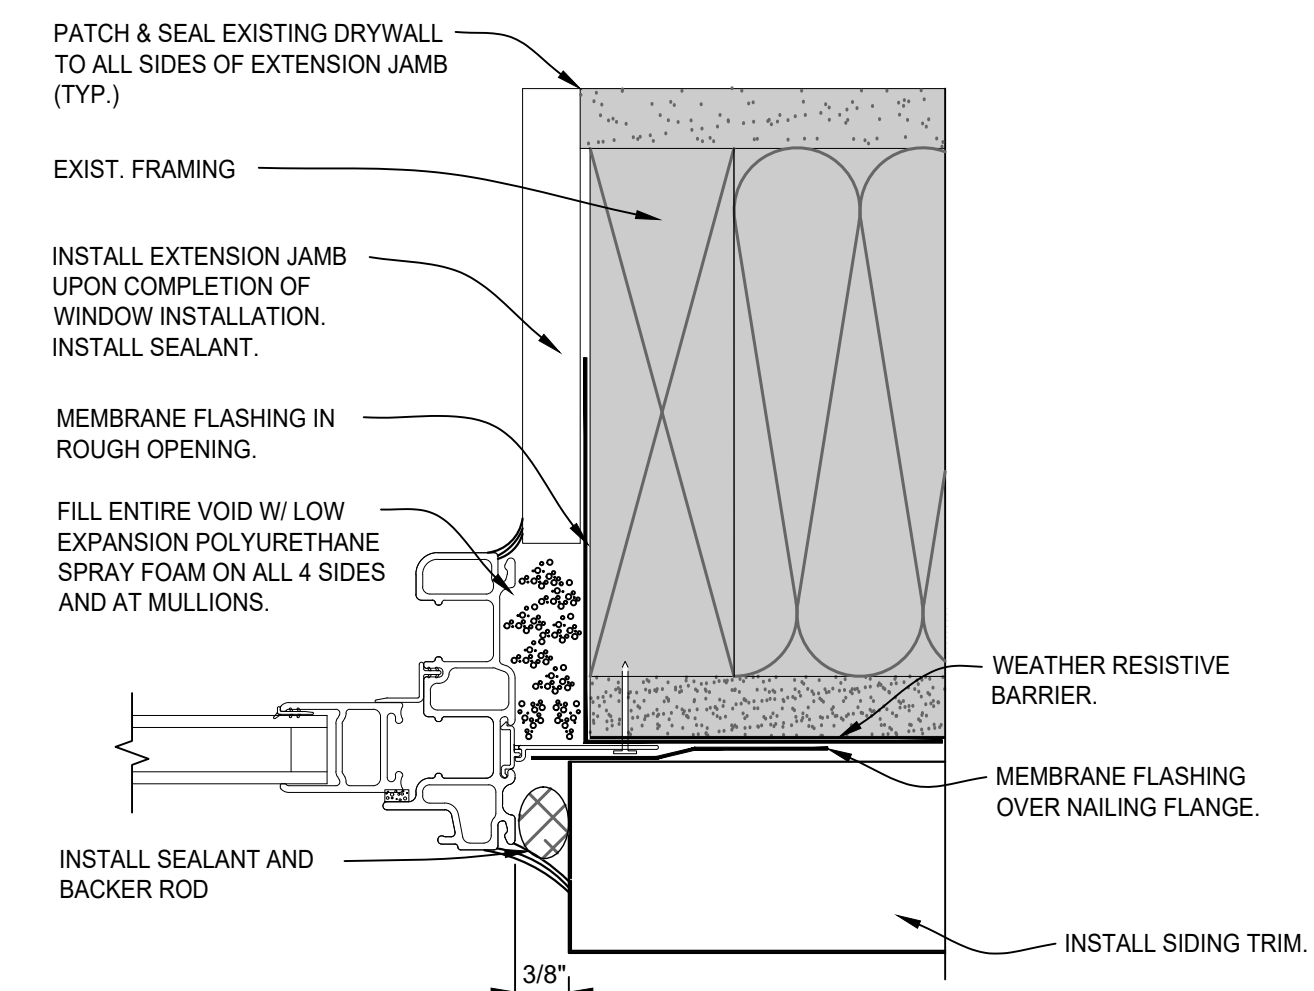
4 TYP. WINDOW JAMB DETAIL
4.1 SCALE: 6" = 1'-0"

CONTRACTOR OPTION: INSTALL EXTENSION JAMB UPON INSTALLATION OF WINDOW & SPRAY FOAM.

REPAIR DRYWALL UPON COMPLETION OF WINDOW INSTALLATION. PAINT & INSTALL SEALANT.

FILL ENTIRE VOID W/ LOW EXPANSION POLYURETHANE SPRAY FOAM ON ALL 4 SIDES AND AT MULLIONS. SEAL BETWEEN WINDOW FRAME AND EXTRUSION JAMB
