Re: Cityview Cooperative – 2021 Exterior Façade Repair Project: Phase I
Structural Repair Addendum – Architectural Code Review
Encompass, Inc. Project # 7311-001

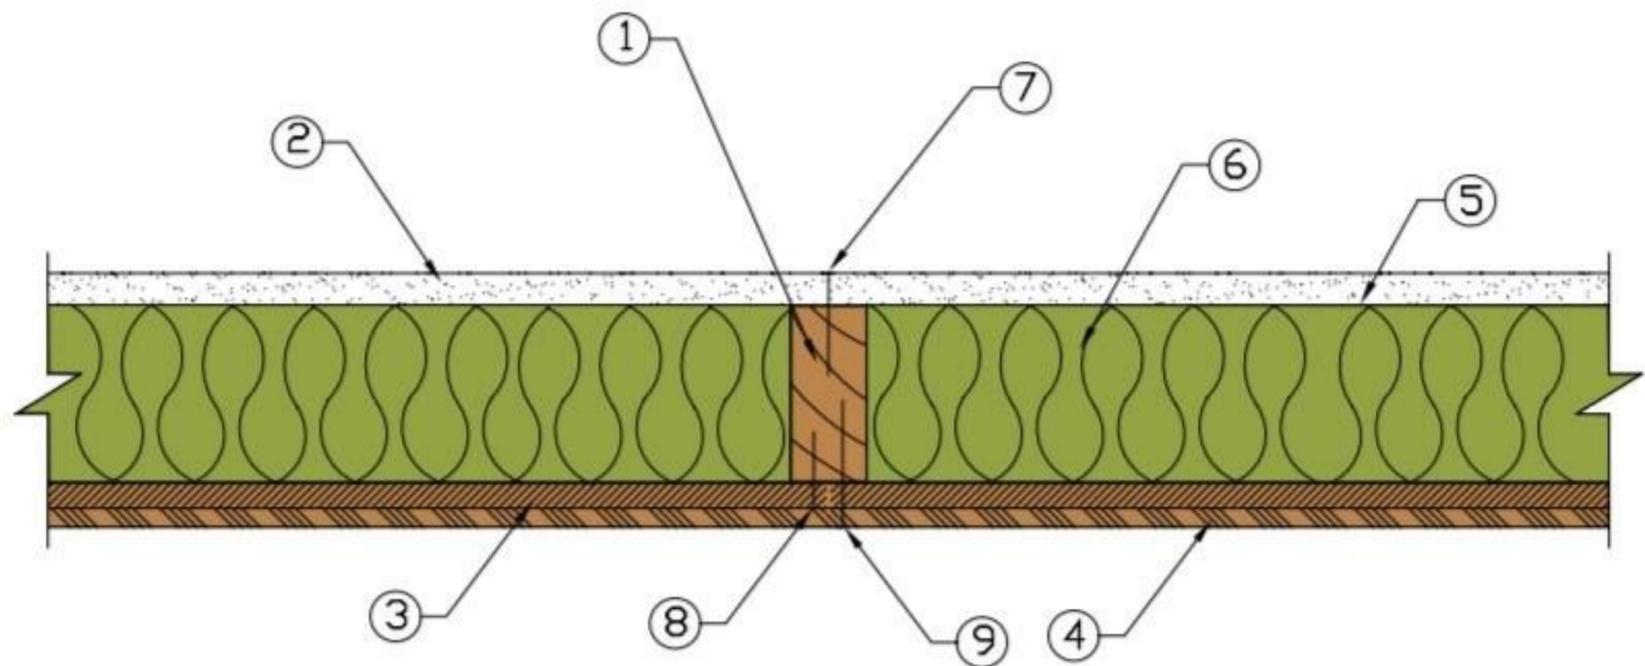
WS4-1.3 One-Hour Fire-Resistive Wood-Frame Wall Assembly

2x4 Wood Stud Wall – 78% Design Load – ASTM E 119/NFPA 251

1. Framing - Nominal 2x4 wood studs, spaced 16 in. o.c., double top plates, single bottom plate
2. Interior Sheathing - 5/8 in. Type X gypsum wallboard, 4 ft. wide, applied vertically, unblocked

3. Exterior Sheathing - 1/2 in. fiberboard sheathing. *Alternate construction - minimum 1/2 in. lumber siding or 1/2 in. wood based sheathing.*
4. Exterior Siding - 3/8 in. hardboard shiplap edge panel siding. *Alternate construction - lumber, wood based, vinyl, or aluminum siding.*

The existing wall assembly is similar to a 1-hour fire rated exterior wall assembly UL-U348 which uses 7/16" exterior plywood (non-fire rated), aligned vertically with horizontal joints blocked. Based on UL-348 this is the material that is recommended to replace the existing exterior ¾" tongue and groove planks at locations of substantial structural repairs. See attached UL document for reference.
